Customer Id: BRIDES
Sample No.: WC0838891
Lab Number: 06009519
Test Package: IND 2

OIL ANALYSIS REPORT

Area
412
Machine Id
621 PELLETIZER MOTOR
Component
Outboard Journal Bearing
Fluid
ESSO NUTO H ISO 68 (1 QTS)

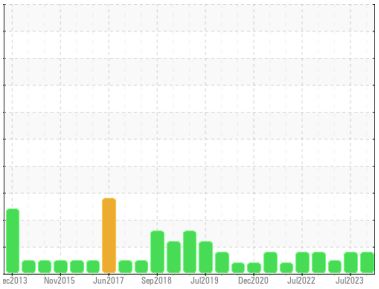
Sample Rating Trend

ISO

ATTENTION	ATTENTION	NORMAL
Sample Status				**ATTENTION**	ATTENTION	NORMAL
Particles >4µm		ASTM D7647	>10000	▲ **16054**	▲ 10717	9941
Oil Cleanliness		ISO 4406 (c)	>20/18/14	▲ **21/18/14**	▲ 21/16/13	20/17/13

The oil change at the time of sampling has been noted. No corrective action is recommended at this time. Resample at the next service interval to monitor.

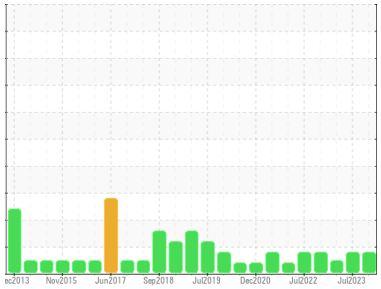
Sample Rating Trend

ISO

Contamination
There is a moderate amount of silt (particulates < 14 microns in size) present in the oil.

Recommendation
The oil change at the time of sampling has been noted. No corrective action is recommended at this time. Resample at the next service interval to monitor.

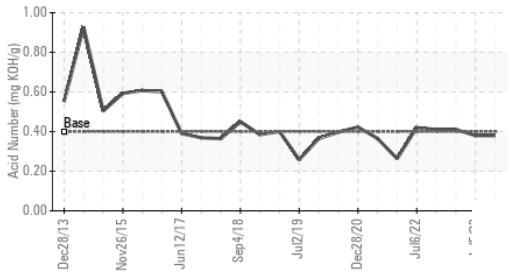
Acid Number

Fluid Condition
The AN level is acceptable for this fluid. The condition of the oil is suitable for further service.

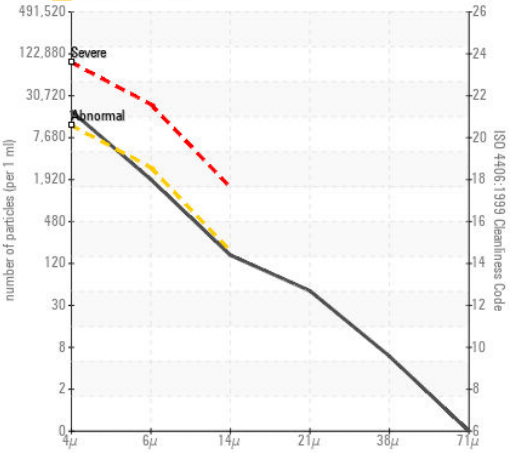
Particle Count

FLUID CLEANLINESS		method	limit/base	current	history1	history2
Particles >4µm		ASTM D7647	>10000	▲ **16054**	▲ 10717	9941
Particles >6µm		ASTM D7647	>2500	**1683**	565	746
Particles >14µm		ASTM D7647	>160	**139**	43	46
Particles >21µm		ASTM D7647	>40	**43**	18	14
Particles >38µm		ASTM D7647	>10	**5**	1	1
Particles >71µm		ASTM D7647	>3	**0**	0	0
Oil Cleanliness		ISO 4406 (c)	>20/18/14	▲ **21/18/14**	▲ 21/16/13	20/17/13
