PROBLEM SUMMARY

Area
412
Machine Id
71 BANBURY MOTOR
Component
Outboard Journal Bearing
Fluid
ESSO NUTO H ISO 68 (1 QTS)

Customer Id: BRIDES
Sample No.: WC0838861
Lab Number: 06009520
Test Package: IND 2

OIL ANALYSIS REPORT

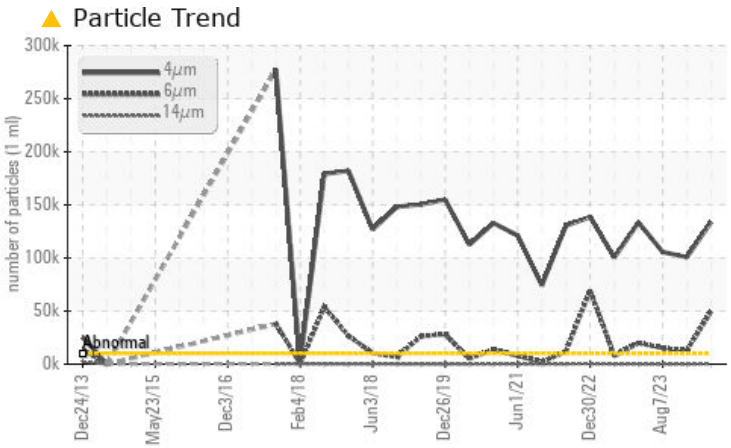
COMPONENT CONDITION SUMMARY

Sample Status				**ABNORMAL**	ABNORMAL	ABNORMAL
Particles >4µm		ASTM D7647	>10000	▲ **133699**	▲ 100684	▲ 105668
Particles >6µm		ASTM D7647	>2500	▲ **49613**	▲ 12880	▲ 15086
Particles >14µm		ASTM D7647	>160	▲ **374**	63	84
Oil Cleanliness		ISO 4406 (c)	>20/18/14	▲ **24/23/16**	▲ 24/21/13	▲ 24/21/14

Contamination
There is a high amount of particulates present in the oil.

The oil change at the time of sampling has been noted. No corrective action is recommended at this time. Resample at the next service interval to monitor.

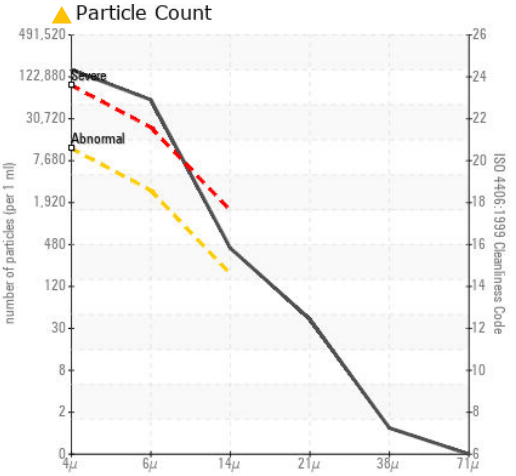
Particle Count

FLUID CLEANLINESS		method	limit/base	current	history1	history2
Particles >4µm		ASTM D7647	>10000	▲ **133699**	▲ 100684	▲ 105668
Particles >6µm		ASTM D7647	>2500	▲ **49613**	▲ 12880	▲ 15086
Particles >14µm		ASTM D7647	>160	▲ **374**	63	84
Particles >21µm		ASTM D7647	>40	**36**	7	8
Particles >38µm		ASTM D7647	>10	**1**	0	0
Particles >71µm		ASTM D7647	>3	**0**	0	0
Oil Cleanliness		ISO 4406 (c)	>20/18/14	▲ **24/23/16**	▲ 24/21/13	▲ 24/21/14
