Customer Id: BRIDES
Sample No.: WC0838935
Lab Number: 06009522
Test Package: IND 2

OIL ANALYSIS REPORT

Area
412
Machine Id
273 BANBURY MOTOR
Component
Inboard Journal Bearing
Fluid
ESSO NUTO H ISO 68 (1 QTS)

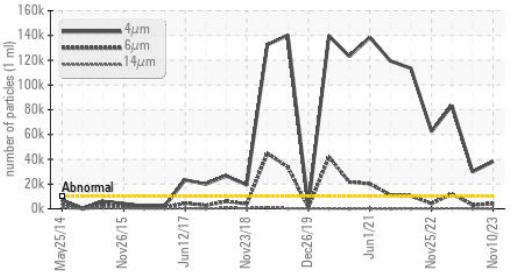
Particle Trend

Contamination
There is a high amount of silt (particulates < 14 microns in size) present in the oil.

FLUID CLEANLINESS		method	limit/base	current	history1	history2
Particles >4µm		ASTM D7647	>10000	▲ **38069**	▲ 29841	▲ 83339
Particles >6µm		ASTM D7647	>2500	▲ **4127**	▲ 3129	▲ 12209
Particles >14µm		ASTM D7647	>160	**80**	116	▲ 457
Particles >21µm		ASTM D7647	>40	**15**	27	▲ 104
Particles >38µm		ASTM D7647	>10	**1**	2	7
Particles >71µm		ASTM D7647	>3	**0**	0	0
Oil Cleanliness		ISO 4406 (c)	>20/18/14	▲ **22/19/13**	▲ 22/19/14	▲ 24/21/16

Recommendation
The oil change at the time of sampling has been noted. No corrective action is recommended at this time. Resample at the next service interval to monitor.
