Customer Id: BRIDES
Sample No.: WC0838937
Lab Number: 06009526
Test Package: IND 2

OIL ANALYSIS REPORT

Area
412
Machine Id
622 BANBURY MOTOR
Component
Outboard Journal Bearing
Fluid
ESSO NUTO H ISO 68 (1 QTS)

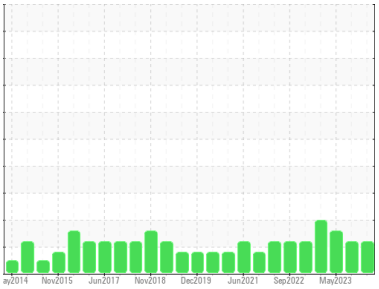
Sample Rating Trend

Sample Status				**ABNORMAL**	ABNORMAL	ABNORMAL
Particles >4µm		ASTM D7647	>10000	▲ **96332**	▲ 92740	▲ 91554
Particles >6µm		ASTM D7647	>2500	▲ **19999**	▲ 15784	▲ 15157
Oil Cleanliness		ISO 4406 (c)	>20/18/14	▲ **24/21/14**	▲ 24/21/14	▲ 24/21/15

No corrective action is recommended at this time. The oil change at the time of sampling has been noted. Resample at the next service interval to monitor.

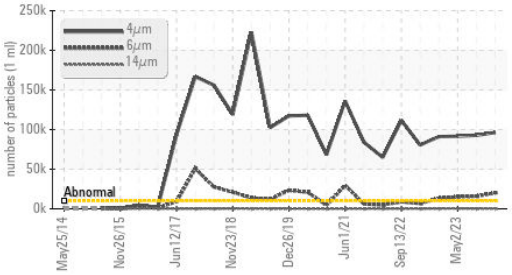
Particle Trend

There is a high amount of silt (particulates < 14 microns in size) present in the oil.

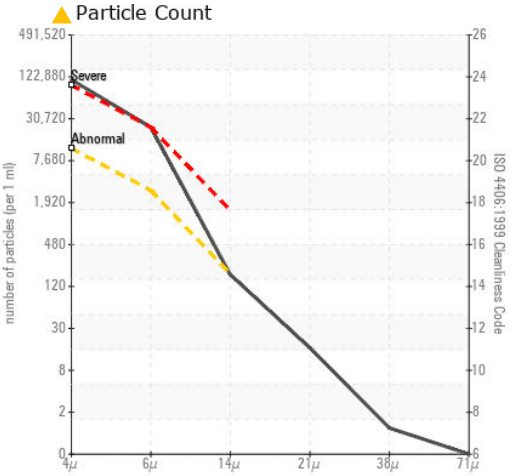
Particle Count

FLUID CLEANLINESS		method	limit/base	current	history1	history2
Particles >4µm		ASTM D7647	>10000	▲ **96332**	▲ 92740	▲ 91554
Particles >6µm		ASTM D7647	>2500	▲ **19999**	▲ 15784	▲ 15157
Particles >14µm		ASTM D7647	>160	**156**	136	▲ 304
Particles >21µm		ASTM D7647	>40	**14**	14	47
Particles >38µm		ASTM D7647	>10	**1**	0	3
Particles >71µm		ASTM D7647	>3	**0**	0	0
Oil Cleanliness		ISO 4406 (c)	>20/18/14	▲ **24/21/14**	▲ 24/21/14	▲ 24/21/15

No corrective action is recommended at this time. The oil change at the time of sampling has been noted. Resample at the next service interval to monitor.
