PROBLEM SUMMARY

Area
412
Machine Id
273 AIRVAYOR
Component
Inboard Bearing
Fluid
MOBIL SHC 630 (10 GAL)

OIL ANALYSIS REPORT

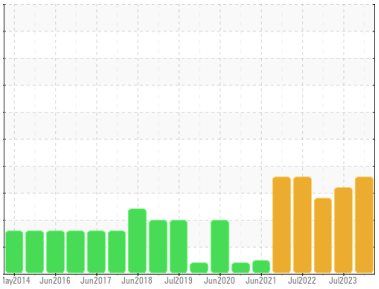
Sample Rating Trend

DIRT

Sample Status				**ABNORMAL**	ABNORMAL	ABNORMAL
Silicon	ppm	ASTM D5185m	>15	▲ **46**	▲ 48	▲ 50
Particles >4µm		ASTM D7647	>10000	▲ **84825**	▲ 88301	▲ 112462
Particles >6µm		ASTM D7647	>2500	▲ **14721**	▲ 9818	▲ 12738
Particles >14µm		ASTM D7647	>160	▲ **853**	▲ 258	99
Particles >21µm		ASTM D7647	>40	▲ **145**	46	13
Oil Cleanliness		ISO 4406 (c)	>20/18/14	▲ **24/21/17**	▲ 24/20/15	▲ 24/21/14

The oil change at the time of sampling has been noted. No corrective action is recommended at this time. Resample at the next service interval to monitor.

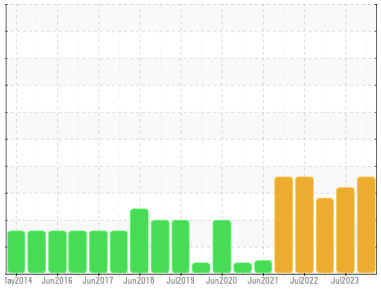
Sample Rating Trend

DIRT

Contamination
There is a high amount of particulates present in the oil. Elemental level of silicon (Si) above normal indicating ingress of seal material.

Recommendation
The oil change at the time of sampling has been noted. No corrective action is recommended at this time. Resample at the next service interval to monitor.
