Customer Id: BRIDES
Sample No.: WC0838860
Lab Number: 06009534
Test Package: IND 2

OIL ANALYSIS REPORT

Area
426
Machine Id
426 STRIP STACKER
Component
Inboard Journal Bearing
Fluid
ESSO NUTO H ISO 68 (1 QTS)

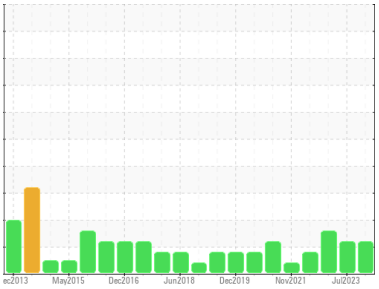
Sample Rating Trend

WEAR

▲ Non-ferrous Metals

No corrective action is recommended at this time. The oil change at the time of sampling has been noted. Resample at the next service interval to monitor. We were unable to perform a particle count due to a high concentration of particles present in this sample.

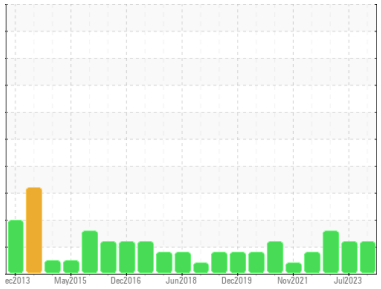
Sample Rating Trend

Wear
All component wear rates are normal.

Contamination
Moderate concentration of visible dirt/debris present in the oil. Elemental level of silicon (Si) above normal indicating ingress of seal material.

Fluid Condition
The AN level is acceptable for this fluid. The condition of the oil is acceptable for the time in service.

Recommendation
No corrective action is recommended at this time. The oil change at the time of sampling has been noted. Resample at the next service interval to monitor. We were unable to perform a particle count due to a high concentration of particles present in this sample.

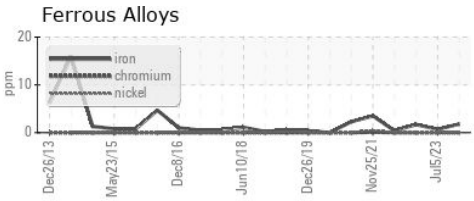
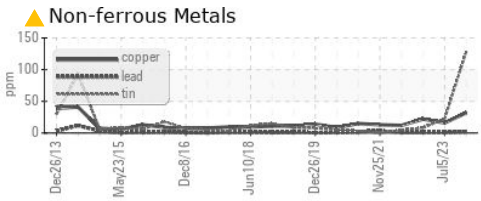
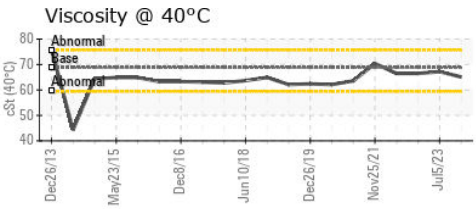
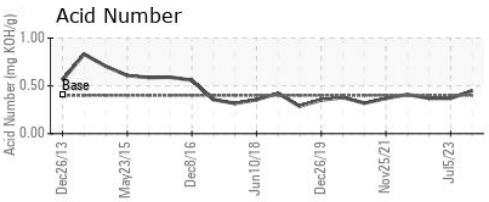
GRAPHS

Sample Status				**ABNORMAL**	ABNORMAL	ABNORMAL
Tin	ppm	ASTM D5185m	>80	▲ **128**	22	8
Debris	scalar	*Visual	NONE	▲ **MODER**	NONE	NONE
