Customer Id: BRIDES
Sample No.: WC0838859
Lab Number: 06009535
Test Package: IND 2

OIL ANALYSIS REPORT

Area
426
Machine Id
426 STRIP STACKER
Component
Outboard Journal Bearing
Fluid
ESSO NUTO H ISO 68 (1 QTS)

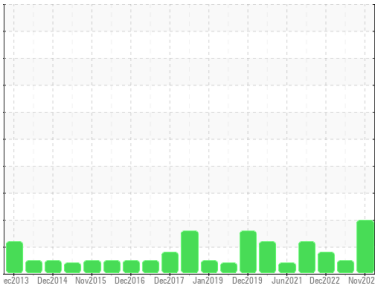
Sample Rating Trend

Sample Status				ABNORMAL	NORMAL	ATTENTION
Particles >4µm		ASTM D7647	>10000	▲ **36875**	9311	▲ 10920
Particles >6µm		ASTM D7647	>2500	▲ **6134**	1492	1615
Particles >14µm		ASTM D7647	>160	▲ **213**	49	30
Particles >21µm		ASTM D7647	>40	▲ **44**	10	3
Oil Cleanliness		ISO 4406 (c)	>20/18/14	▲ **22/20/15**	20/18/13	▲ 21/18/12

Contamination
There is a high amount of particulates present in the oil.

No corrective action is recommended at this time. The oil change at the time of sampling has been noted. Resample at the next service interval to monitor.

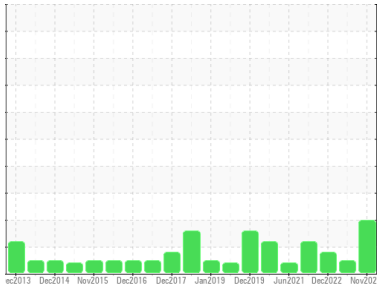
Sample Rating Trend

FLUID CLEANLINESS		method	limit/base	current	history1	history2
Particles >4µm		ASTM D7647	>10000	▲ **36875**	9311	▲ 10920
Particles >6µm		ASTM D7647	>2500	▲ **6134**	1492	1615
Particles >14µm		ASTM D7647	>160	▲ **213**	49	30
Particles >21µm		ASTM D7647	>40	▲ **44**	10	3
Particles >38µm		ASTM D7647	>10	**2**	1	1
Particles >71µm		ASTM D7647	>3	**0**	0	0
Oil Cleanliness		ISO 4406 (c)	>20/18/14	▲ **22/20/15**	20/18/13	▲ 21/18/12

Recommendation
No corrective action is recommended at this time. The oil change at the time of sampling has been noted. Resample at the next service interval to monitor.
