Customer Id: BRIDES
Sample No.: WC0838841
Lab Number: 06009538
Test Package: IND 2

OIL ANALYSIS REPORT

Area
426
Machine Id
105-106 MILL MOTOR
Component
Outboard Journal Bearing
Fluid
ESSO NUTO H ISO 68 (1 QTS)

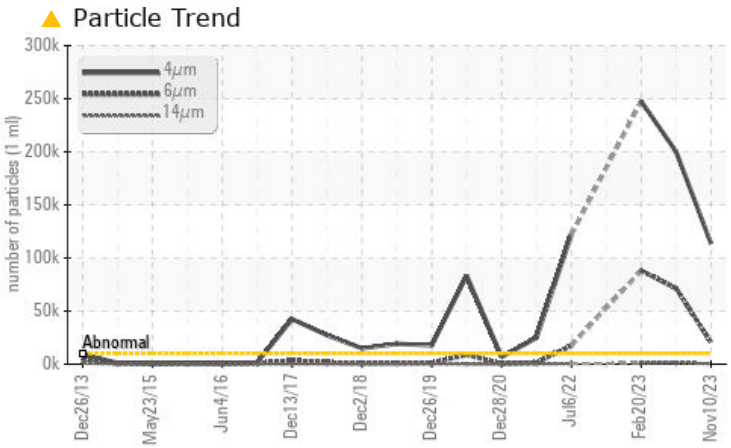
COMPONENT CONDITION SUMMARY

Sample Status				**ABNORMAL**	ABNORMAL	ABNORMAL
Particles >4µm		ASTM D7647	>10000	▲ **113734**	▲ 200146	▲ 247624
Particles >6µm		ASTM D7647	>2500	▲ **20419**	▲ 71436	▲ 88011
Particles >14µm		ASTM D7647	>160	▲ **421**	▲ 1263	▲ 1003
Particles >21µm		ASTM D7647	>40	▲ **79**	▲ 186	▲ 113
Oil Cleanliness		ISO 4406 (c)	>20/18/14	▲ **24/22/16**	▲ 25/23/17	▲ 25/24/17

Contamination
There is a high amount of particulates present in the oil.

The oil change at the time of sampling has been noted. No corrective action is recommended at this time. Resample at the next service interval to monitor.

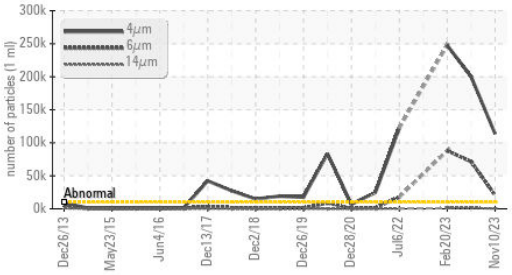
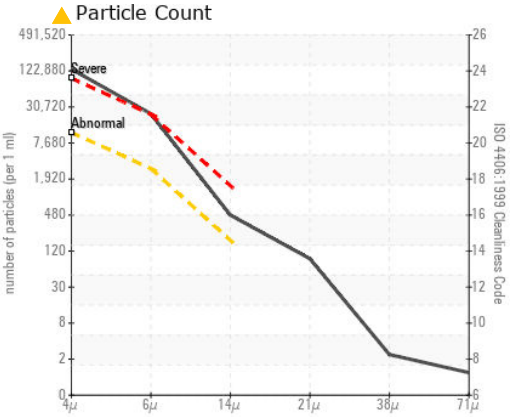
Particle Trend

FLUID CLEANLINESS		method	limit/base	current	history1	history2
Particles >4µm		ASTM D7647	>10000	▲ **113734**	▲ 200146	▲ 247624
Particles >6µm		ASTM D7647	>2500	▲ **20419**	▲ 71436	▲ 88011
Particles >14µm		ASTM D7647	>160	▲ **421**	▲ 1263	▲ 1003
Particles >21µm		ASTM D7647	>40	▲ **79**	▲ 186	▲ 113
Particles >38µm		ASTM D7647	>10	**2**	2	8
Particles >71µm		ASTM D7647	>3	**1**	0	1
Oil Cleanliness		ISO 4406 (c)	>20/18/14	▲ **24/22/16**	▲ 25/23/17	▲ 25/24/17

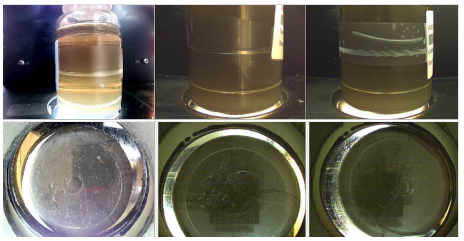
SAMPLE IMAGES	method	limit/base	current	history1	history2
Color					
Bottom

VISUAL		method	limit/base	current	history1	history2
White Metal	scalar	*Visual	NONE	**NONE**	NONE	NONE
Yellow Metal	scalar	*Visual	NONE	**NONE**	NONE	NONE
Precipitate	scalar	*Visual	NONE	**NONE**	NONE	NONE
Silt	scalar	*Visual	NONE	**NONE**	NONE	NONE
Debris	scalar	*Visual	NONE	**NONE**	NONE	VLITE
Sand/Dirt	scalar	*Visual	NONE	**NONE**	NONE	NONE
Appearance	scalar	*Visual	NORML	**NORML**	NORML	NORML
Odor	scalar	*Visual	NORML	**NORML**	NORML	NORML
Emulsified Water	scalar	*Visual	>2	**NEG**	NEG	NEG
Free Water	scalar	*Visual		**NEG**	NEG	NEG
