OIL ANALYSIS REPORT

Area
RIG 5
Machine Id
HYUNDAI HL757-9A R5-LOADER NKL
Component
Diesel Engine
Fluid
CHEVRON 15W40 (--- GAL)

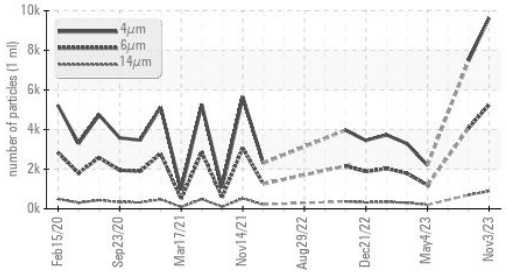
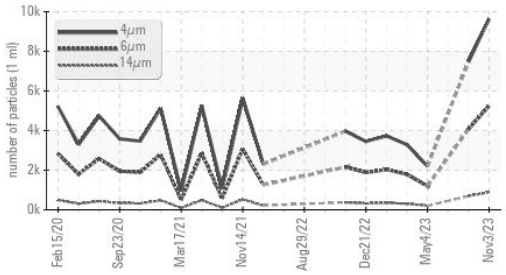
Particle Trend

Contamination
There is a moderate amount of particulates present in the oil.

FLUID CLEANLINESS		method	limit/base	current	history1	history2
Particles >4µm		ASTM D7647		**9631**	7473	---
Particles >6µm		ASTM D7647	>5000	▲ **5246**	4071	---
Particles >14µm		ASTM D7647	>640	▲ **893**	▲ 693	---
Particles >21µm		ASTM D7647	>160	▲ **301**	▲ 233	---
Particles >38µm		ASTM D7647	>40	▲ **46**	36	---
Particles >71µm		ASTM D7647	>10	**5**	4	---
Oil Cleanliness		ISO 4406 (c)	>19/16	▲ **20/17**	▲ 19/17	---

Recommendation
No corrective action is recommended at this time. Resample at the next service interval to monitor.

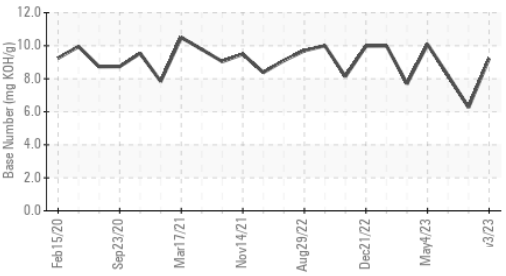
Base Number

Fluid Condition
The BN result indicates that there is suitable alkalinity remaining in the oil. The condition of the oil is suitable for further service.

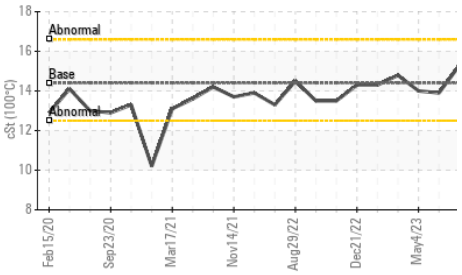
Viscosity @ 100°C

FLUID PROPERTIES		method	limit/base	current	history1	history2
Visc @ 100°C	cSt	ASTM D445	14.4	**14.3**	15.3	13.9

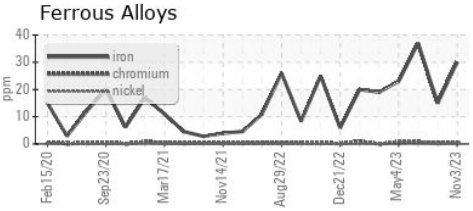
Ferrous Alloys

Wear
All component wear rates are normal.
