Machine Id
CF6201 (S/N 00881-003-1-01-01)
Component
Gearbox
Fluid
MOBIL GLYGOYLE 100 (--- GAL)

Customer Id: FLIFAI
Sample No.: USP246083
Lab Number: 06010874
Test Package: IND 2

OIL ANALYSIS REPORT

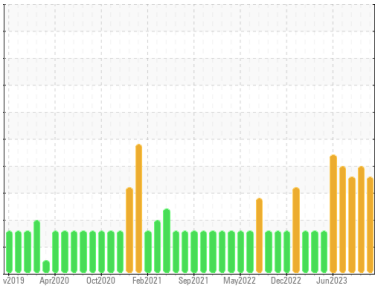
Sample Rating Trend

WATER

Sample Status				**ABNORMAL**	ABNORMAL	ABNORMAL
Water	%	ASTM D6304	>0.2	▲ **0.330**	▲ 0.350	▲ 0.373
ppm Water	ppm	ASTM D6304	>2000	▲ **3300**	▲ 3500	▲ 3730
Particles >4µm		ASTM D7647	>20000	▲ **78536**	▲ 141941	▲ 168211
Particles >6µm		ASTM D7647	>5000	▲ **19847**	▲ 57606	▲ 48653
Particles >14µm		ASTM D7647	>640	▲ **1143**	▲ 3937	▲ 2153
Particles >21µm		ASTM D7647	>160	▲ **233**	▲ 1019	▲ 542
Oil Cleanliness		ISO 4406 (c)	>21/19/16	▲ **23/21/17**	▲ 24/23/19	▲ 25/23/18

We advise that you check for the source of water entry. We recommend you service the filters on this component if applicable. Resample at the next service interval to monitor.

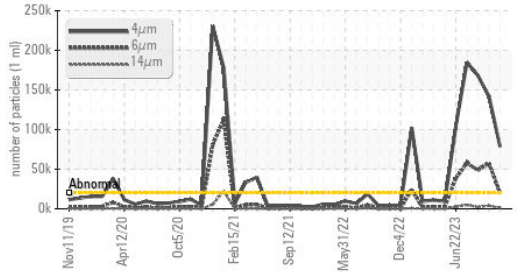
Particle Trend

Contamination
There is a high amount of particulates present in the oil. There is a light concentration of water present in the oil.

Recommendation
We advise that you check for the source of water entry. We recommend you service the filters on this component if applicable. Resample at the next service interval to monitor.

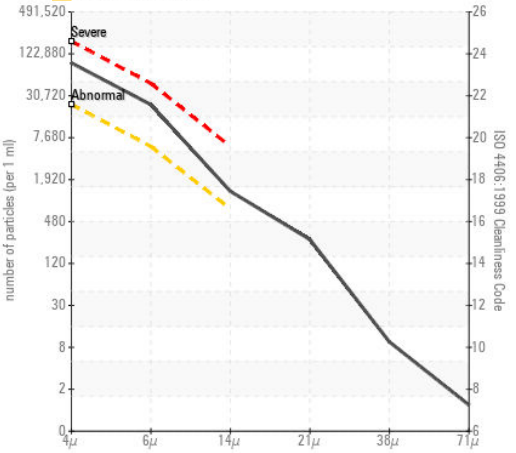
Particle Count

FLUID CLEANLINESS		method	limit/base	current	history1	history2
Particles >4µm		ASTM D7647	>20000	▲ **78536**	▲ 141941	▲ 168211
Particles >6µm		ASTM D7647	>5000	▲ **19847**	▲ 57606	▲ 48653
Particles >14µm		ASTM D7647	>640	▲ **1143**	▲ 3937	▲ 2153
Particles >21µm		ASTM D7647	>160	▲ **233**	▲ 1019	▲ 542
Particles >38µm		ASTM D7647	>40	**8**	▲ 51	26
Particles >71µm		ASTM D7647	>10	**1**	3	2
Oil Cleanliness		ISO 4406 (c)	>21/19/16	▲ **23/21/17**	▲ 24/23/19	▲ 25/23/18
