PROBLEM SUMMARY

Area
BLEACH O2
Machine Id
BX060 POST02 PRESS NE (S/N 0661-03-02-040-040-040)
Component
Bearing
Fluid
NOT GIVEN (4 GAL)

OIL ANALYSIS REPORT

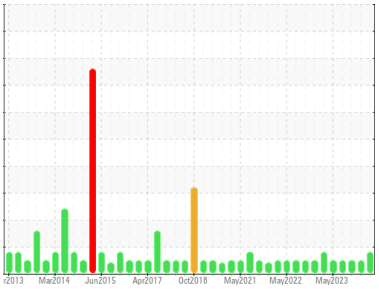
Sample Rating Trend

WEAR

Sample Status				**ABNORMAL**	NORMAL	NORMAL
Iron	ppm	ASTM D5185m	>20	▲ **82**	2	40

Resample at the next service interval to monitor.
