Customer Id: ADVGAH
Sample No.: KCPA011338
Lab Number: 06013338
Test Package: IND 2

OIL ANALYSIS REPORT

Machine Id
7024294 (S/N 1106)
Component
Compressor
Fluid
KAESER SIGMA (OEM) S-460 (--- GAL)

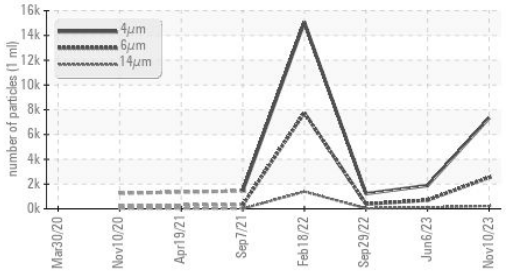
Particle Trend

Contamination
There is a high amount of particulates present in the oil.

FLUID CLEANLINESS		method	limit/base	current	history1	history2
Particles >4µm		ASTM D7647		**7341**	1883	1224
Particles >6µm		ASTM D7647	>1300	▲ **2531**	696	385
Particles >14µm		ASTM D7647	>80	▲ **235**	▲ 110	36
Particles >21µm		ASTM D7647	>20	▲ **52**	▲ 31	10
Particles >38µm		ASTM D7647	>4	**1**	1	0
Particles >71µm		ASTM D7647	>3	**0**	0	0
Oil Cleanliness		ISO 4406 (c)	>--/17/13	▲ **20/19/15**	▲ 18/17/14	17/16/12

Recommendation
No corrective action is recommended at this time. The filter change at the time of sampling has been noted. Resample at the next service interval to monitor.
