PROBLEM SUMMARY

Machine Id
9B
Component
Gearbox
Fluid
TEXACO REGAL OIL R&O 220 (--- GAL)

OIL ANALYSIS REPORT

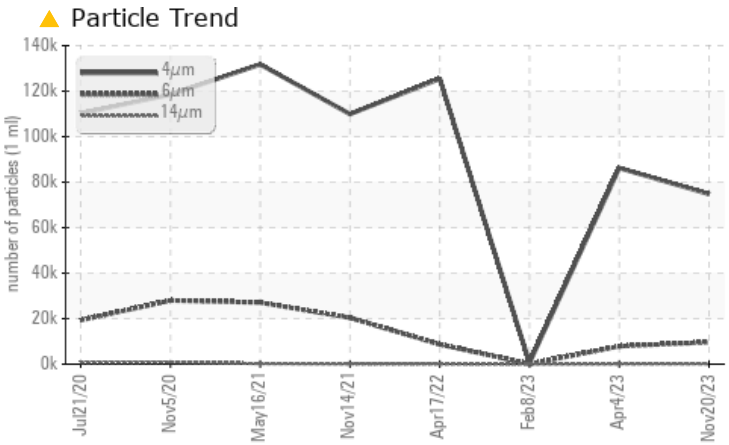
COMPONENT CONDITION SUMMARY

ATTENTION	ATTENTION	NORMAL
Sample Status				**ATTENTION**	ATTENTION	NORMAL
Particles >6µm		ASTM D7647	>5000	▲ **9659**	▲ 7851	120
Oil Cleanliness		ISO 4406 (c)	>--/19/16	▲ **23/20/14**	▲ 24/20/13	16/14/11

Contamination
There is a moderate amount of silt (particulates < 14 microns in size) present in the oil.

No corrective action is recommended at this time.
Resample at the next service interval to monitor.

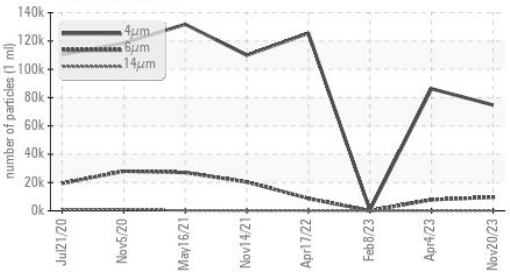
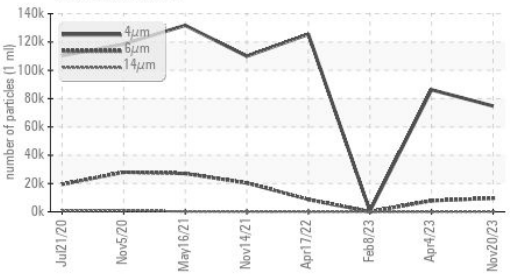
Particle Trend

FLUID CLEANLINESS		method	limit/base	current	history1	history2
Particles >4µm		ASTM D7647		**74766**	86214	556
Particles >6µm		ASTM D7647	>5000	▲ **9659**	▲ 7851	120
Particles >14µm		ASTM D7647	>640	**135**	71	11
Particles >21µm		ASTM D7647	>160	**20**	7	2
Particles >38µm		ASTM D7647	>40	**2**	0	0
Particles >71µm		ASTM D7647	>10	**2**	0	0
Oil Cleanliness		ISO 4406 (c)	>--/19/16	▲ **23/20/14**	▲ 24/20/13	16/14/11

Recommendation
No corrective action is recommended at this time. Resample at the next service interval to monitor.

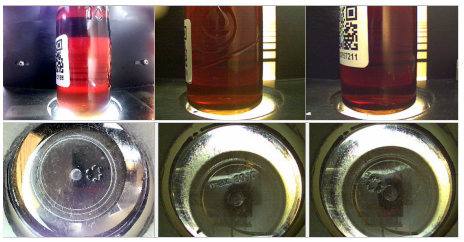
SAMPLE IMAGES	method	limit/base	current	history1	history2
Color					
Bottom

VISUAL		method	limit/base	current	history1	history2
White Metal	scalar	*Visual	NONE	**NONE**	NONE	NONE
Yellow Metal	scalar	*Visual	NONE	**NONE**	NONE	NONE
Precipitate	scalar	*Visual	NONE	**NONE**	NONE	NONE
Silt	scalar	*Visual	NONE	**NONE**	NONE	NONE
Debris	scalar	*Visual	NONE	**NONE**	NONE	NONE
Sand/Dirt	scalar	*Visual	NONE	**NONE**	NONE	NONE
Appearance	scalar	*Visual	NORML	**NORML**	NORML	NORML
Odor	scalar	*Visual	NORML	**NORML**	NORML	NORML
Emulsified Water	scalar	*Visual	>0.2	**NEG**	NEG	NEG
Free Water	scalar	*Visual		**NEG**	NEG	NEG
