Machine Id
SB12MGB
Component
Gearbox
Fluid
GEAR OIL ISO 320 (--- GAL)

Customer Id: KOBPIN
Sample No.: ST43906
Lab Number: 06014537
Test Package: IND 2

OIL ANALYSIS REPORT

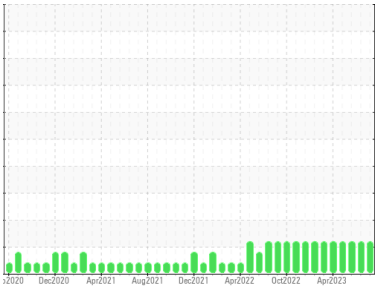
Sample Rating Trend

Sample Status				ABNORMAL	ABNORMAL	ABNORMAL
Particles >4µm		ASTM D7647	>40000	▲ **80057**	▲ 85430	▲ 89472
Particles >6µm		ASTM D7647	>5000	▲ **10097**	▲ 12563	▲ 13810
Oil Cleanliness		ISO 4406 (c)	>22/19/16	▲ **24/21/13**	▲ 24/21/14	▲ 24/21/13

There is a high amount of particulates present in the oil.

We recommend you service the filters on this component if applicable. Resample at the next service interval to monitor. Due to an abnormal test result it is recommended to contact Stauff Corp at (201)-444-7800 for help resolving the issue.

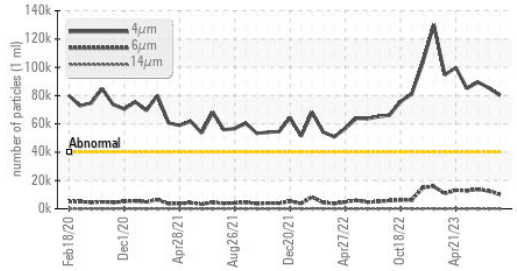
Particle Trend

FLUID CLEANLINESS		method	limit/base	current	history1	history2
Particles >4µm		ASTM D7647	>40000	▲ **80057**	▲ 85430	▲ 89472
Particles >6µm		ASTM D7647	>5000	▲ **10097**	▲ 12563	▲ 13810
Particles >14µm		ASTM D7647	>640	**55**	104	79
Particles >21µm		ASTM D7647	>160	**6**	14	7
Particles >38µm		ASTM D7647	>40	**0**	0	0
Particles >71µm		ASTM D7647	>10	**0**	0	0
Oil Cleanliness		ISO 4406 (c)	>22/19/16	▲ **24/21/13**	▲ 24/21/14	▲ 24/21/13

We recommend you service the filters on this component if applicable. Resample at the next service interval to monitor. Due to an abnormal test result it is recommended to contact Stauff Corp at (201)-444-7800 for help resolving the issue.
