Area
EBAY
Machine Id
SB13MGB
Component
Gearbox
Fluid
GEAR OIL ISO 320 (--- GAL)

Customer Id: KOBPIN
Sample No.: ST46008
Lab Number: 06014538
Test Package: IND 2

OIL ANALYSIS REPORT

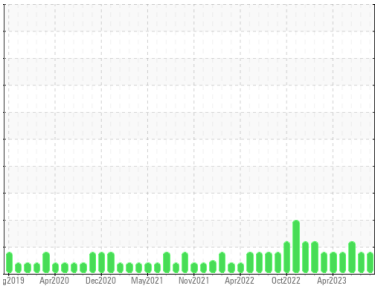
Sample Rating Trend

Sample Status				**ATTENTION**	ATTENTION	ATTENTION
Particles >4µm		ASTM D7647	>40000	▲ **55288**	▲ 50069	▲ 60333
Oil Cleanliness		ISO 4406 (c)	>22/19/16	▲ **23/19/13**	▲ 23/19/13	▲ 23/20/14

Resample at the next service interval to monitor. Due to an abnormal test result it is recommended to contact Stauff Corp at (201)-444-7800 for help resolving the issue.

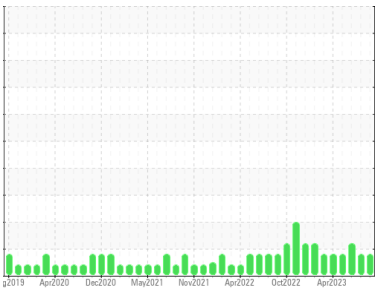
Sample Rating Trend

There is a moderate amount of silt (particulates < 6 microns in size) present in the oil.

FLUID CLEANLINESS	method	limit/base	current	history1	history2
Particles >4µm	ASTM D7647	>40000	▲ **55288**	▲ 50069	▲ 60333
Particles >6µm	ASTM D7647	>5000	**4818**	3914	▲ 6681
Particles >14µm	ASTM D7647	>640	**76**	43	119
Particles >21µm	ASTM D7647	>160	**16**	9	18
Particles >38µm	ASTM D7647	>40	**1**	0	0
Particles >71µm	ASTM D7647	>10	**0**	0	0
Oil Cleanliness	ISO 4406 (c)	>22/19/16	▲ **23/19/13**	▲ 23/19/13	▲ 23/20/14

Resample at the next service interval to monitor. Due to an abnormal test result it is recommended to contact Stauff Corp at (201)-444-7800 for help resolving the issue.
