Customer Id: SULLAP
Sample No.: RP0033680
Lab Number: 06014557
Test Package: IND 2

OIL ANALYSIS REPORT

Machine Id
SULLAIR M1037
Component
Compressor
Fluid
ROYAL PURPLE SYNFILM 46 (15 GAL)

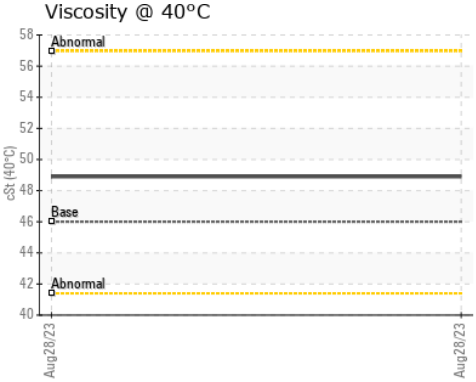
Viscosity @ 40°C

Fluid Condition
The AN level is acceptable for this fluid. The condition of the oil is suitable for further service.

FLUID PROPERTIES		method	limit/base	current	history1	history2
Visc @ 40°C	cSt	ASTM D445	46	**48.9**	---	---

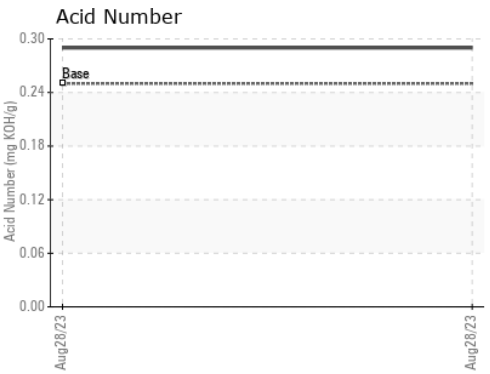
FLUID DEGRADATION		method	limit/base	current	history1	history2
Acid Number (AN)	mg KOH/g	ASTM D8045	0.25	**0.29**	---	---
