Machine Id
10061537 HOMOGENIZER 2 (S/N 28810606)
Component
Gearbox
Fluid
LUBRIPLATE SFGO ULTRA 220 (4 GAL)

OIL ANALYSIS REPORT

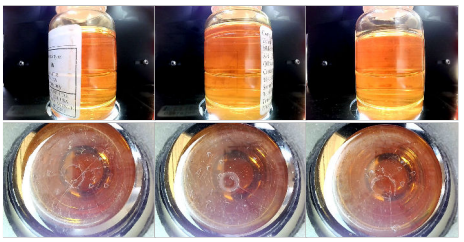
SAMPLE IMAGES	method	limit/base	current	history1	history2
Color					
Bottom

Contamination
There is a moderate amount of silt (particulates < 6 microns in size) present in the oil.

Recommendation
Resample at the next service interval to monitor.
