PROBLEM SUMMARY

Area
COLORADO/443/EG - EXCAVATOR
Machine Id
20.407L [COLORADO^443^EG - EXCAVATOR]
Component
Diesel Engine
Fluid
MOBIL DELVAC 1300 SUPER15W40 (--- GAL)

OIL ANALYSIS REPORT

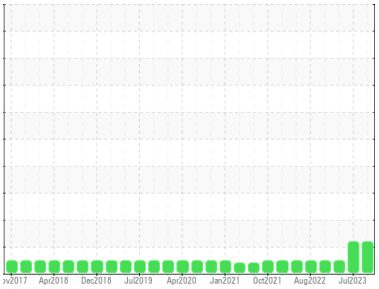
Sample Rating Trend

GLYCOL

We advise that you check for the source of the coolant leak. Check for low coolant level. Oil and filter change at the time of sampling has been noted. We recommend an early resample to monitor this condition.

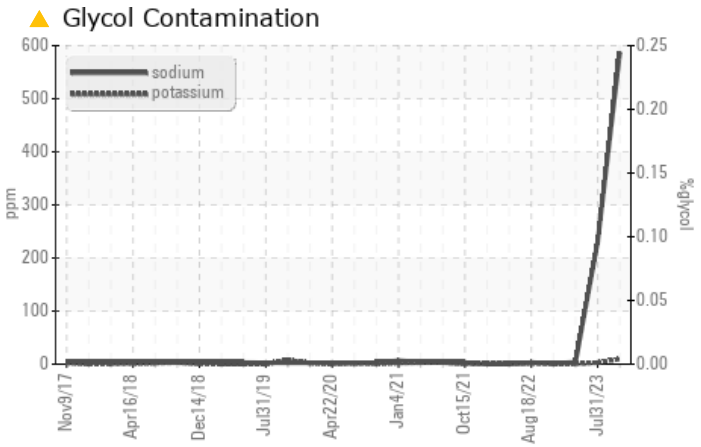
COMPONENT CONDITION SUMMARY

Sample Status				ABNORMAL	ABNORMAL	NORMAL
Sodium	ppm	ASTM D5185m		▲ 587	▲ 231	4

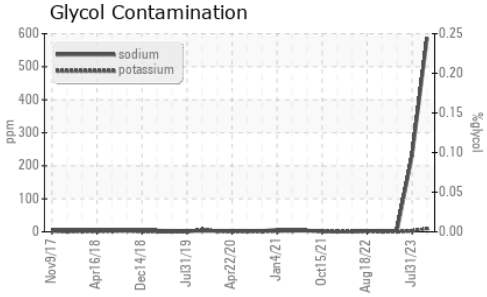
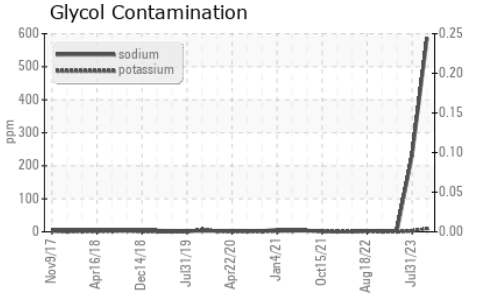
Glycol Contamination

Contamination
Sodium and/or potassium levels remain high.

CONTAMINANTS		method	limit/base	current	history1	history2
Silicon	ppm	ASTM D5185m	>25	**8**	7	6
Sodium	ppm	ASTM D5185m		▲ **587**	▲ 231	4
Potassium	ppm	ASTM D5185m	>20	**10**	3	<1
Glycol	%	*ASTM D2982		**NEG**	NEG	NEG

Recommendation
We advise that you check for the source of the coolant leak. Check for low coolant level. Oil and filter change at the time of sampling has been noted. We recommend an early resample to monitor this condition.

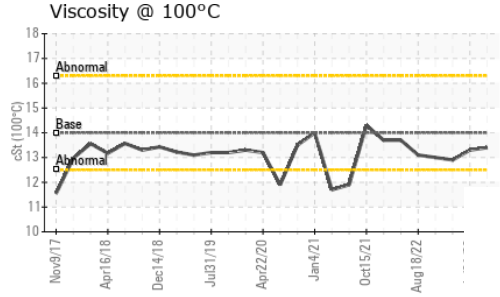
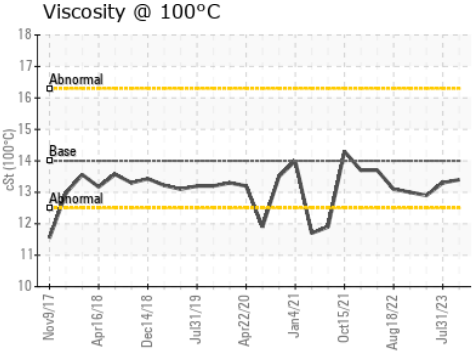
Viscosity @ 100°C

FLUID PROPERTIES		method	limit/base	current	history1	history2
Visc @ 100°C	cSt	ASTM D445	14	**13.4**	13.3	12.9

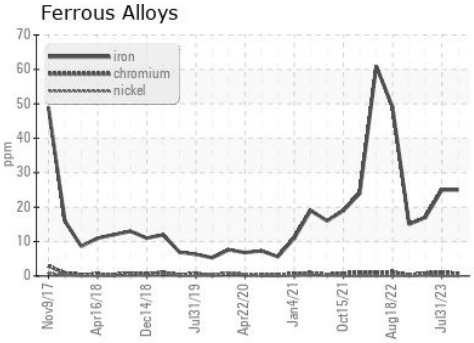
Ferrous Alloys

Wear
All component wear rates are normal.

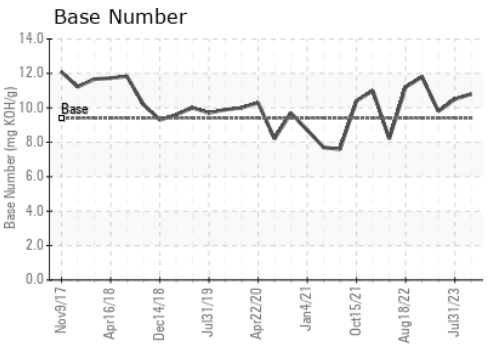
Base Number

Fluid Condition
The BN result indicates that there is suitable alkalinity remaining in the oil.
