Machine Id
KAESER SM 7.5 8105335 (S/N 1213)
Component
Compressor
Fluid
KAESER SIGMA (OEM) S-460 (--- GAL)

Customer Id: QUADUN
Sample No.: KCPA009796
Lab Number: 06016397
Test Package: IND 2

OIL ANALYSIS REPORT

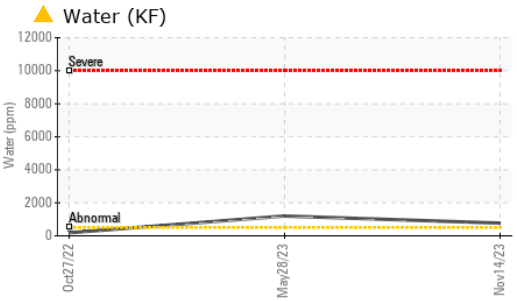
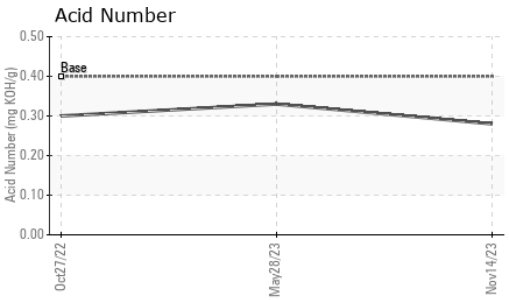
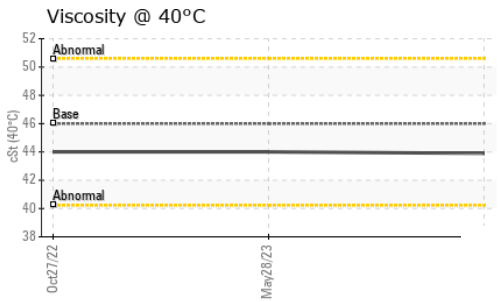
SAMPLE IMAGES	method	limit/base	current	history1	history2
Color					
Bottom

There is a light concentration of water present in the oil. High concentration of visible dirt/debris present in the oil.

VISUAL		method	limit/base	current	history1	history2
White Metal	scalar	*Visual	NONE	**NONE**	NONE	NONE
Yellow Metal	scalar	*Visual	NONE	**NONE**	NONE	NONE
Precipitate	scalar	*Visual	NONE	**NONE**	NONE	NONE
Silt	scalar	*Visual	NONE	**NONE**	▲ MODER	NONE
Debris	scalar	*Visual	NONE	▲ **HEAVY**	NONE	NONE
Sand/Dirt	scalar	*Visual	NONE	**NONE**	NONE	NONE
Appearance	scalar	*Visual	NORML	**NORML**	▲ HAZY	NORML
Odor	scalar	*Visual	NORML	**NORML**	NORML	NORML
Emulsified Water	scalar	*Visual	>0.05	**0.2%**	0.2%	NEG
Free Water	scalar	*Visual		**NEG**	▲ 2.0	NEG

We recommend you service the filters on this component. We were unable to perform a particle count due to a high concentration of particles present in this sample. We advise that you stop the unit and follow the water drain-off procedure for this component. We recommend an early resample in 500 hours to monitor this condition.
