Customer Id: POEHAN
Sample No.: USP244919
Lab Number: 06016434
Test Package: IND 2

OIL ANALYSIS REPORT

Machine Id
C-807
Component
Gearbox
Fluid
MOBIL SHC 630 (--- GAL)

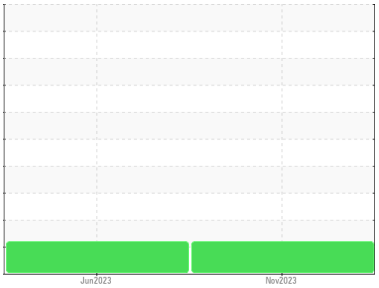
VISUAL METAL

Sample Status				**ABNORMAL**	ABNORMAL	---
White Metal	scalar	*Visual	NONE	▲ **MODER**	▲ MODER	---

We recommend you service the filters on this component if applicable. Resample at the next service interval to monitor. We were unable to perform a particle count due to metal particles present in this sample.

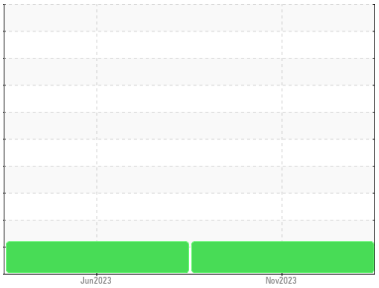
VISUAL METAL

Moderate concentration of visible metal present. All component wear rates are normal.

We recommend you service the filters on this component if applicable. Resample at the next service interval to monitor. We were unable to perform a particle count due to metal particles present in this sample.
