PROBLEM SUMMARY

Machine Id
CWAY_U2220 CWAY_U2220_P2220
Component
Non-Drive End Pump
Fluid
ROYAL PURPLE SYNFILM GT 32 (--- GAL)

OIL ANALYSIS REPORT

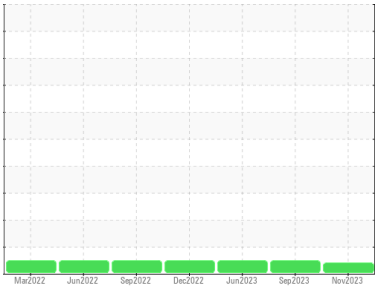
Sample Rating Trend

VIS DEBRIS

Sample Status				**ABNORMAL**	NORMAL	NORMAL
Debris	scalar	*Visual	NONE	▲ **MODER**	NONE	LIGHT

We suspect abnormal contamination may be due to sampling method. No corrective action is recommended at this time. Resample at the next service interval to monitor.

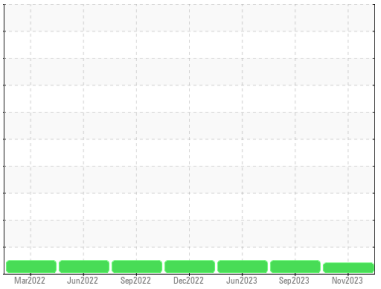
Sample Rating Trend

VIS DEBRIS

Contamination
Moderate concentration of visible dirt/debris present in the oil. The water content is negligible.

Recommendation
We suspect abnormal contamination may be due to sampling method. No corrective action is recommended at this time. Resample at the next service interval to monitor.
