OIL ANALYSIS REPORT

Area
VENEZIA
Machine Id
VENEZIA 2241
Component
Rear Differential
Fluid
NOT GIVEN (--- GAL)

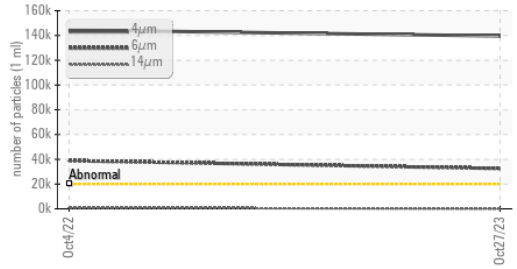
Particle Trend

Contamination
There is a high amount of silt (particulates < 14 microns in size) present in the oil.

FLUID CLEANLINESS		method	limit/base	current	history1	history2
Particles >4µm		ASTM D7647	>20000	▲ **139593**	▲ 144442	---
Particles >6µm		ASTM D7647	>5000	▲ **32528**	▲ 38885	---
Particles >14µm		ASTM D7647	>640	**94**	▲ 763	---
Particles >21µm		ASTM D7647	>160	**14**	113	---
Particles >38µm		ASTM D7647	>40	**1**	7	---
Particles >71µm		ASTM D7647	>10	**0**	1	---
Oil Cleanliness		ISO 4406 (c)	>21/19/16	▲ **24/22/14**	▲ 24/22/17	---

Recommendation
No corrective action is recommended at this time. Resample at the next service interval to monitor.
