OIL ANALYSIS REPORT

Area
VENEZIA
Machine Id
VENEZIA 2241
Component
Front Differential
Fluid
NOT GIVEN (--- GAL)

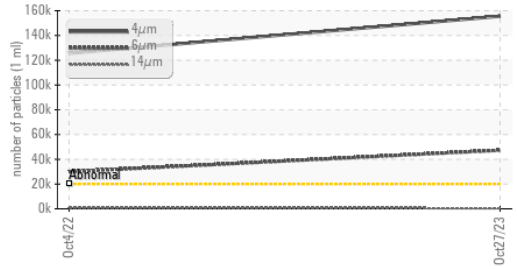
Particle Trend

Contamination
There is a high amount of silt (particulates < 14 microns in size) present in the oil.

FLUID CLEANLINESS		method	limit/base	current	history1	history2
Particles >4µm		ASTM D7647	>20000	▲ **155568**	▲ 125575	---
Particles >6µm		ASTM D7647	>5000	▲ **47266**	▲ 29962	---
Particles >14µm		ASTM D7647	>640	**403**	▲ 797	---
Particles >21µm		ASTM D7647	>160	**65**	133	---
Particles >38µm		ASTM D7647	>40	**2**	11	---
Particles >71µm		ASTM D7647	>10	**0**	1	---
Oil Cleanliness		ISO 4406 (c)	>21/19/16	▲ **24/23/16**	▲ 24/22/17	---

Recommendation
No corrective action is recommended at this time. Resample at the next service interval to monitor.
