PROBLEM SUMMARY

Area
FRONTIER II [200006776]
Machine Id
68WEA86856
Component
Wind Turbine Gearbox
Fluid
FUCHS RENOLIN CLP ISO 320 (--- LTR)

OIL ANALYSIS REPORT

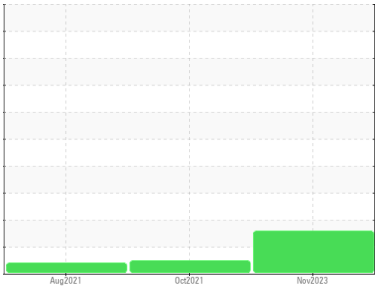
Sample Rating Trend

▲ Particle Trend

Sample Status				ATTENTION	NORMAL	ABNORMAL
Particles >6µm		ASTM D7647	>2500	▲ **3943**	160	▲ 909
Particles >14µm		ASTM D7647	>320	▲ **366**	19	25
Particles >21µm		ASTM D7647	>80	▲ **89**	5	4
Oil Cleanliness		ISO 4406 (c)	>--/18/15	▲ **21/19/16**	18/14/11	▲ 22/17/12

No corrective action is recommended at this time.
Resample at the next service interval to monitor.

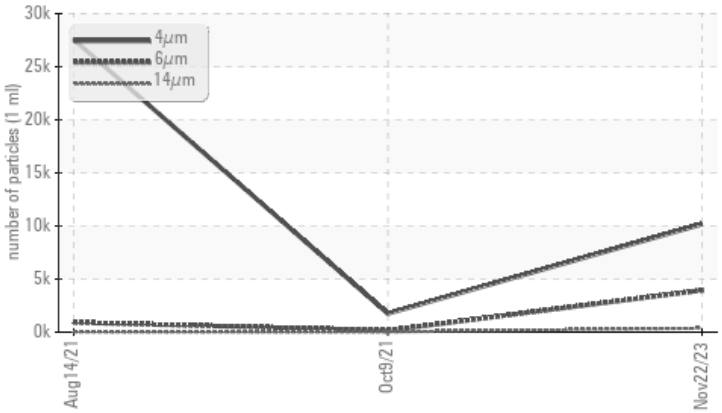
Contamination
There is a moderate amount of particulates present in the oil.

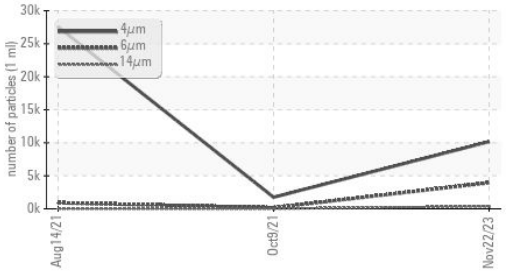
Particle Trend

FLUID CLEANLINESS		method	limit/base	current	history1	history2
Particles >4µm		ASTM D7647		**10174**	1751	27560
Particles >6µm		ASTM D7647	>2500	▲ **3943**	160	▲ 909
Particles >14µm		ASTM D7647	>320	▲ **366**	19	25
Particles >21µm		ASTM D7647	>80	▲ **89**	5	4
Particles >38µm		ASTM D7647	>20	**2**	0	0
Particles >71µm		ASTM D7647	>4	**0**	0	0
Oil Cleanliness		ISO 4406 (c)	>--/18/15	▲ **21/19/16**	18/14/11	▲ 22/17/12

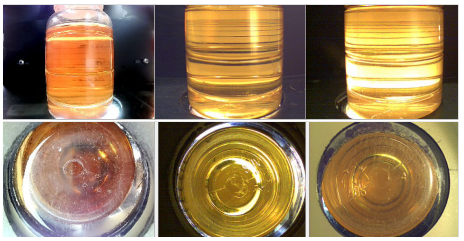
SAMPLE IMAGES	method	limit/base	current	history1	history2
Color					
Bottom

VISUAL		method	limit/base	current	history1	history2
White Metal	scalar	*Visual	NONE	**NONE**	NONE	NONE
Yellow Metal	scalar	*Visual	NONE	**NONE**	NONE	NONE
Precipitate	scalar	*Visual	NONE	**NONE**	NONE	NONE
Silt	scalar	*Visual	NONE	**NONE**	NONE	NONE
Debris	scalar	*Visual	NONE	**LIGHT**	NONE	NONE
Sand/Dirt	scalar	*Visual	NONE	**NONE**	NONE	NONE
Appearance	scalar	*Visual	NORML	**NORML**	NORML	NORML
Odor	scalar	*Visual	NORML	**NORML**	NORML	NORML
Emulsified Water	scalar	*Visual	>0.05	**NEG**	NEG	NEG
Free Water	scalar	*Visual		**NEG**	NEG	NEG
