Machine Id
KAESER ASD 40T 6008069 (S/N 1279)
Component
Compressor
Fluid
KAESER SIGMA (OEM) S-460 (--- GAL)

Customer Id: AMAEDI
Sample No.: KC125889
Lab Number: 06026417
Test Package: IND 2

OIL ANALYSIS REPORT

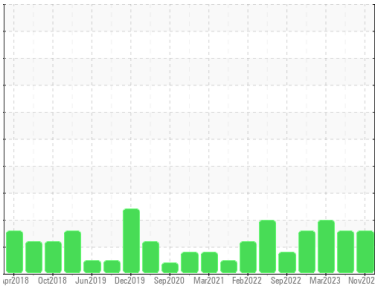
Sample Rating Trend

Sample Status				ABNORMAL	ABNORMAL	ABNORMAL
Particles >6µm		ASTM D7647	>1300	▲ **9475**	▲ 2384	▲ 5792
Particles >14µm		ASTM D7647	>80	▲ **662**	▲ 263	▲ 566
Particles >21µm		ASTM D7647	>20	▲ **123**	▲ 59	▲ 173
Oil Cleanliness		ISO 4406 (c)	>--/17/13	▲ **22/20/17**	▲ 20/18/15	▲ 21/20/16

Contamination
There is a high amount of particulates present in the oil.

No corrective action is recommended at this time. The filter change at the time of sampling has been noted. Resample at the next service interval to monitor.

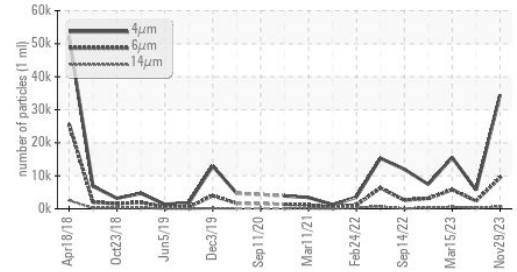
Particle Trend

FLUID CLEANLINESS		method	limit/base	current	history1	history2
Particles >4µm		ASTM D7647		**34492**	5689	15512
Particles >6µm		ASTM D7647	>1300	▲ **9475**	▲ 2384	▲ 5792
Particles >14µm		ASTM D7647	>80	▲ **662**	▲ 263	▲ 566
Particles >21µm		ASTM D7647	>20	▲ **123**	▲ 59	▲ 173
Particles >38µm		ASTM D7647	>4	**2**	2	▲ 6
Particles >71µm		ASTM D7647	>3	**0**	0	1
Oil Cleanliness		ISO 4406 (c)	>--/17/13	▲ **22/20/17**	▲ 20/18/15	▲ 21/20/16

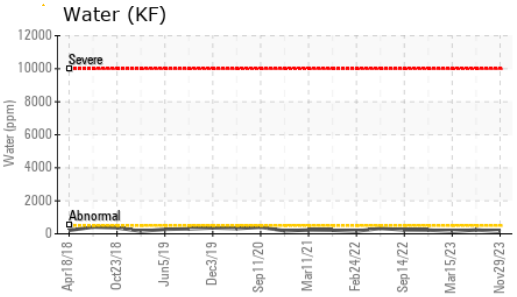
Water (KF)

CONTAMINANTS		method	limit/base	current	history1	history2
Silicon	ppm	ASTM D5185m	>25	**<1**	1	1
Sodium	ppm	ASTM D5185m		**24**	20	14
Potassium	ppm	ASTM D5185m	>20	**4**	4	2
Water	%	ASTM D6304	>0.05	**0.014**	0.023	0.015
ppm Water	ppm	ASTM D6304	>500	**143**	235.5	155.5

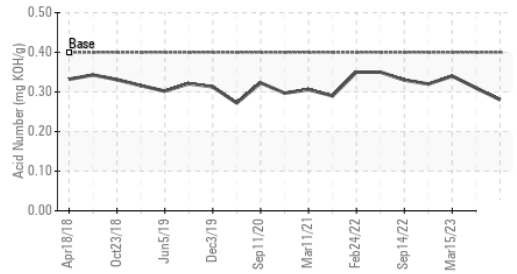
Fluid Condition
The AN level is acceptable for this fluid. The condition of the oil is suitable for further service.

FLUID DEGRADATION		method	limit/base	current	history1	history2
Acid Number (AN)	mg KOH/g	ASTM D8045	0.4	**0.28**	0.31	0.34

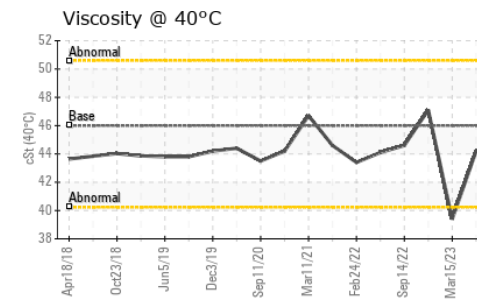
Viscosity @ 40°C

FLUID PROPERTIES		method	limit/base	current	history1	history2
Visc @ 40°C	cSt	ASTM D445	46	**44.4**	44.2	39.4
