Customer Id: AMAEDI
Sample No.: KC127412
Lab Number: 06026419
Test Package: IND 2

OIL ANALYSIS REPORT

Machine Id
KAESER ASD 40T 6025209 (S/N 1281)
Component
Compressor
Fluid
KAESER SIGMA (OEM) S-460 (--- GAL)

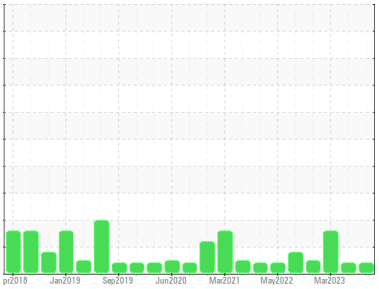
Sample Rating Trend

VIS DEBRIS

Sample Status				**ABNORMAL**	ABNORMAL	ABNORMAL
Debris	scalar	*Visual	NONE	▲ **MODER**	▲ MODER	LIGHT

No corrective action is recommended at this time. The filter change at the time of sampling has been noted. Resample at the next service interval to monitor. We were unable to perform a particle count due to a high concentration of particles present in this sample.

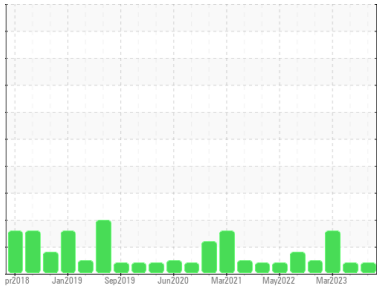
Sample Rating Trend

VIS DEBRIS

Contamination
Moderate concentration of visible dirt/debris present in the oil.

Recommendation
No corrective action is recommended at this time. The filter change at the time of sampling has been noted. Resample at the next service interval to monitor. We were unable to perform a particle count due to a high concentration of particles present in this sample.
