PROBLEM SUMMARY

Area
Alamo Plant/Cryogenic/Compressor
Machine Id
C-162 (S/N 10241A53177582Z)
Component
Refrigeration Compressor
Fluid
TULCO LUBSOIL SYN RL WI 100 (250 GAL)

OIL ANALYSIS REPORT

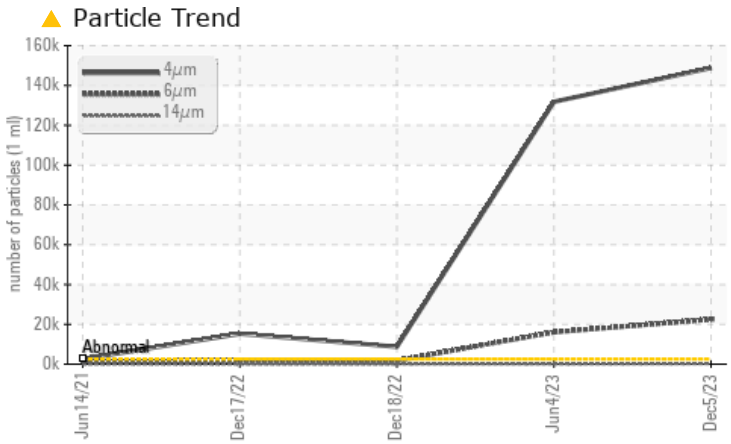
COMPONENT CONDITION SUMMARY

Sample Status				**ABNORMAL**	ABNORMAL	ABNORMAL
Particles >4µm		ASTM D7647	>2500	▲ **148833**	▲ 131788	▲ 8715
Particles >6µm		ASTM D7647	>320	▲ **22473**	▲ 16060	▲ 1788
Particles >14µm		ASTM D7647	>80	▲ **220**	66	50
Particles >21µm		ASTM D7647	>20	▲ **27**	6	7
Oil Cleanliness		ISO 4406 (c)	>18/15/13	▲ **24/22/15**	▲ 24/21/13	▲ 20/18/13

Contamination
There is a high amount of particulates present in the oil.

We recommend you service the filters on this component. Resample at the next service interval to monitor.

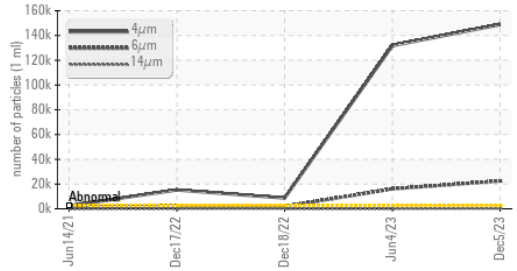
Particle Trend

FLUID CLEANLINESS		method	limit/base	current	history1	history2
Particles >4µm		ASTM D7647	>2500	▲ **148833**	▲ 131788	▲ 8715
Particles >6µm		ASTM D7647	>320	▲ **22473**	▲ 16060	▲ 1788
Particles >14µm		ASTM D7647	>80	▲ **220**	66	50
Particles >21µm		ASTM D7647	>20	▲ **27**	6	7
Particles >38µm		ASTM D7647	>4	**0**	0	0
Particles >71µm		ASTM D7647	>3	**0**	0	0
Oil Cleanliness		ISO 4406 (c)	>18/15/13	▲ **24/22/15**	▲ 24/21/13	▲ 20/18/13
