Customer Id: ENECYG
Sample No.: RP0033129
Lab Number: 06026566
Test Package: IND 2

OIL ANALYSIS REPORT

Machine Id
CYG_MLU3
Component
Outboard Pump
Fluid
NOT GIVEN (--- GAL)

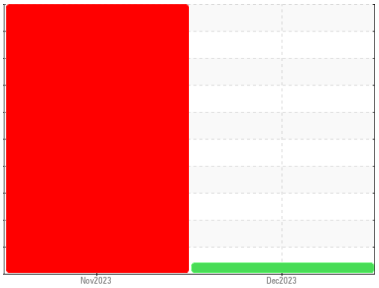
Sample Rating Trend

VIS DEBRIS

Sample Status				**ABNORMAL**	SEVERE	---
Debris	scalar	*Visual	NONE	▲ **MODER**	NONE	---

We suspect abnormal contamination may be due to sampling method. No corrective action is recommended at this time. Resample at the next service interval to monitor.

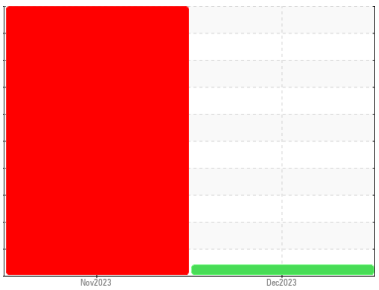
Sample Rating Trend

VIS DEBRIS

Contamination
Moderate concentration of visible dirt/debris present in the oil. The water content is negligible.

Recommendation
We suspect abnormal contamination may be due to sampling method. No corrective action is recommended at this time. Resample at the next service interval to monitor.
