Customer Id: ENECYG
Sample No.: RP0032981
Lab Number: 06026586
Test Package: IND 2

OIL ANALYSIS REPORT

Machine Id
CYG_MLU6
Component
Inboard Pump
Fluid
NOT GIVEN (--- GAL)

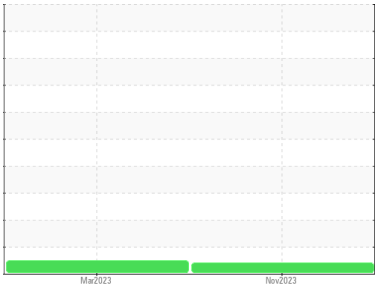
Sample Rating Trend

VIS DEBRIS

Contamination
Moderate concentration of visible dirt/debris present in the oil. The water content is negligible.

Recommendation
We suspect abnormal contamination may be due to sampling method. No corrective action is recommended at this time. Resample at the next service interval to monitor.
