Area
P-ACO-32
Machine Id
TRASH COMPACTOR - MASONITE
Component
Hydraulic System

Customer Id: UCPROWES
Sample No.: UCH06027690
Lab Number: 06027690
Test Package: IND 2

OIL ANALYSIS REPORT

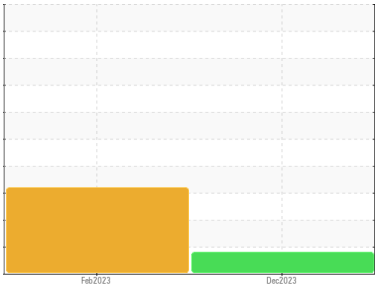
Sample Rating Trend

Sample Status				**ATTENTION**	ABNORMAL	---
Particles >4µm		ASTM D7647	>5000	▲ **8325**	▲ 38692	---
Oil Cleanliness		ISO 4406 (c)	>19/17/14	▲ **20/17/13**	▲ 22/20/16	---

No corrective action is recommended at this time.
Resample at the next service interval to monitor.

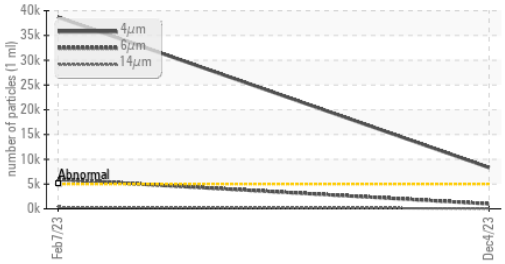
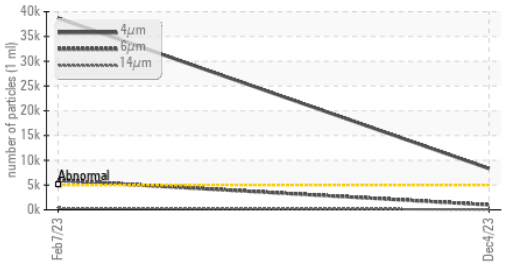
Particle Trend

There is a moderate amount of silt (particulates < 6 microns in size) present in the oil.

FLUID CLEANLINESS		method	limit/base	current	history1	history2
Particles >4µm		ASTM D7647	>5000	▲ **8325**	▲ 38692	---
Particles >6µm		ASTM D7647	>1300	**1000**	▲ 5922	---
Particles >14µm		ASTM D7647	>160	**59**	▲ 356	---
Particles >21µm		ASTM D7647	>40	**17**	▲ 67	---
Particles >38µm		ASTM D7647	>10	**2**	5	---
Particles >71µm		ASTM D7647	>3	**0**	0	---
Oil Cleanliness		ISO 4406 (c)	>19/17/14	▲ **20/17/13**	▲ 22/20/16	---

No corrective action is recommended at this time. Resample at the next service interval to monitor.

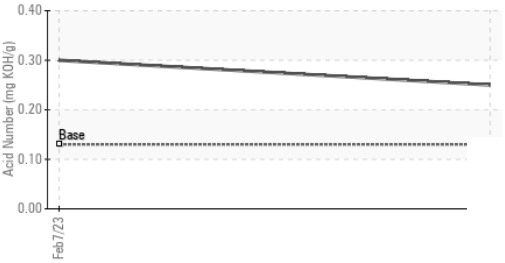
The AN level is acceptable for this fluid. The condition of the oil is suitable for further service.

FLUID DEGRADATION		method	limit/base	current	history1	history2
Acid Number (AN)	mg KOH/g	ASTM D8045	0.13	**0.25**	0.30	---

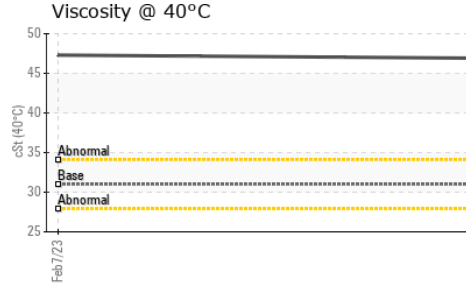
Viscosity @ 40°C

FLUID PROPERTIES		method	limit/base	current	history1	history2
Visc @ 40°C	cSt	ASTM D445	31	**46.9**	47.3	---
