Area
COOLING TOWER
Machine Id
Motor - WEST COOLING TOWER PUMP (S/N P613M)
Component
Bearing
Fluid
TURBINE OIL ISO 32 (6 QTS)

Customer Id: HEXDIB
Sample No.: PLS0000654
Lab Number: 06028590
Test Package: IND 2

OIL ANALYSIS REPORT

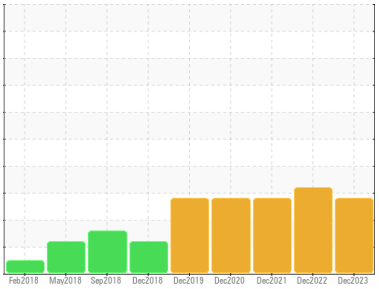
Sample Rating Trend

DEGRADATION

Oil profile does not match the reference oil on file. Please provide a reference oil sample for the lab to test against. No other action required at this time. Resample at next normal interval.

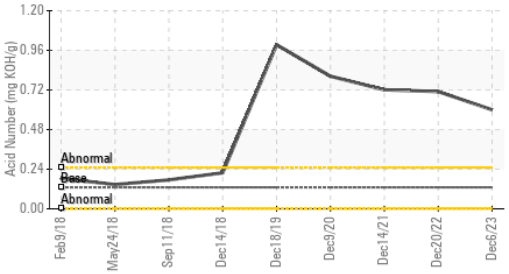
FLUID DEGRADATION		method	limit/base	current	history1	history2
Oxidation	Abs/.1mm	*ASTM D7414		**2.3**	2.4	2.2
Acid Number (AN)	mg KOH/g	ASTM D8045	0.13	▲ **0.60**	▲ 0.71	▲ 0.721

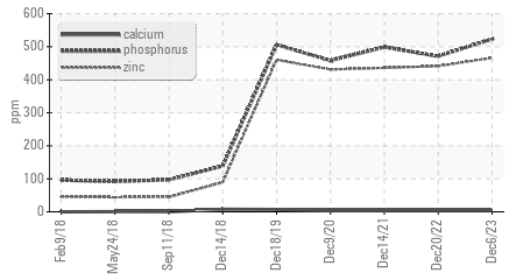
Additives

ADDITIVES		method	limit/base	current	history1	history2
Boron	ppm	ASTM D5185m	5	**5**	0	2
Barium	ppm	ASTM D5185m	5	**0**	0	0
Molybdenum	ppm	ASTM D5185m	5	▲ **214**	▲ 219	▲ 232
Manganese	ppm	ASTM D5185m		**<1**	0	0
Magnesium	ppm	ASTM D5185m	5	**<1**	0	0
Calcium	ppm	ASTM D5185m	10	**4**	4	4
Phosphorus	ppm	ASTM D5185m	275	▲ **523**	▲ 471	▲ 499
Zinc	ppm	ASTM D5185m	7	▲ **466**	▲ 441	▲ 436
Sulfur	ppm	ASTM D5185m	400	▲ **1675**	▲ 1478	▲ 1559

Recommendation
Oil profile does not match the reference oil on file. Please provide a reference oil sample for the lab to test against. No other action required at this time. Resample at next normal interval.

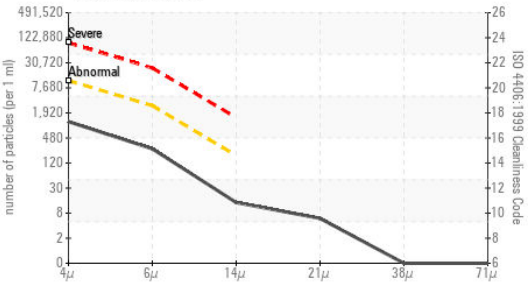
Particle Count

FLUID CLEANLINESS		method	limit/base	current	history1	history2
Particles >4µm		ASTM D7647	>10000	**1041**	1683	1281
Particles >6µm		ASTM D7647	>2500	**232**	198	150
Particles >14µm		ASTM D7647	>160	**12**	6	7
Particles >21µm		ASTM D7647	>40	**5**	1	1
Particles >38µm		ASTM D7647	>10	**0**	0	0
Particles >71µm		ASTM D7647	>3	**0**	0	0
Oil Cleanliness		ISO 4406 (c)	>20/18/14	**17/15/11**	18/15/10	17/14/10

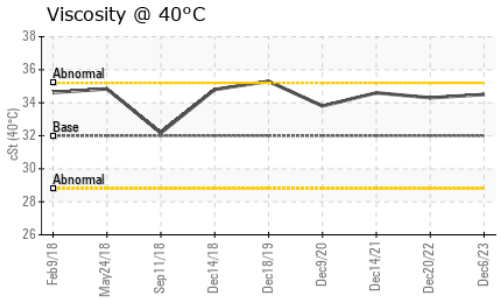
Viscosity @ 40°C

FLUID PROPERTIES		method	limit/base	current	history1	history2
Visc @ 40°C	cSt	ASTM D445	32	**34.5**	34.3	34.6

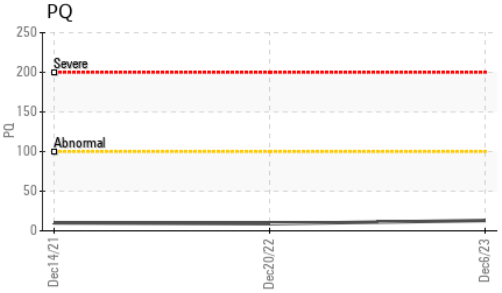
WEAR METALS		method	limit/base	current	history1	history2
PQ		ASTM D8184		**13**	9	10
Iron	ppm	ASTM D5185m	>20	**0**	<1	<1
Chromium	ppm	ASTM D5185m	>20	**0**	0	0
Nickel	ppm	ASTM D5185m	>20	**0**	0	0
Titanium	ppm	ASTM D5185m		**0**	0	0
Silver	ppm	ASTM D5185m		**0**	0	0
Aluminum	ppm	ASTM D5185m	>20	**2**	0	0
Lead	ppm	ASTM D5185m	>20	**0**	0	0
Copper	ppm	ASTM D5185m	>20	**2**	1	1
Tin	ppm	ASTM D5185m	>20	**0**	0	0
Antimony	ppm	ASTM D5185m		**---**	---	0
Vanadium	ppm	ASTM D5185m		**0**	0	0
Cadmium	ppm	ASTM D5185m		**0**	0	0
