Machine Id
KAESER 7287420 (S/N 1063)
Component
Compressor
Fluid
KAESER SIGMA (OEM) S-460 (--- GAL)

Customer Id: INTBELKC
Sample No.: KC06028684
Lab Number: 06028684
Test Package: IND 2

OIL ANALYSIS REPORT

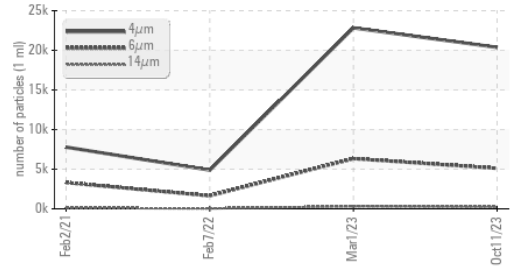
Particle Trend

Contamination
There is a high amount of particulates present in the oil.

FLUID CLEANLINESS		method	limit/base	current	history1	history2
Particles >4µm		ASTM D7647		**20370**	22831	4885
Particles >6µm		ASTM D7647	>1300	▲ **5110**	▲ 6332	▲ 1642
Particles >14µm		ASTM D7647	>80	▲ **227**	▲ 313	45
Particles >21µm		ASTM D7647	>20	▲ **54**	▲ 49	6
Particles >38µm		ASTM D7647	>4	**3**	2	0
Particles >71µm		ASTM D7647	>3	**0**	0	0
Oil Cleanliness		ISO 4406 (c)	>--/17/13	▲ **22/20/15**	▲ 22/20/15	▲ 18/13

Recommendation
No corrective action is recommended at this time. The filter change at the time of sampling has been noted. Resample at the next service interval to monitor.
