Machine Id
## WHITNEY ASSEMBLY 1634
Component
**Hydraulic System**
Fluid
**DUBOIS PRELUBE ISO 46 (140 GAL)**

**Customer Id:** LARATT
**Sample No.:** ST44428
**Lab Number:** 06029377
**Test Package:** IND 2

# OIL ANALYSIS REPORT

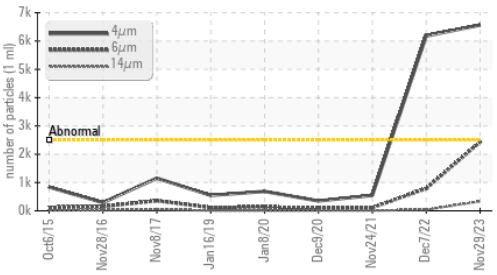
Particle Trend

**Contamination**
There is a moderate amount of particulates (2 to 100 microns in size) present in the oil. The system cleanliness is above the acceptable limit for the target ISO 4406 cleanliness code.

| FLUID CLEANLINESS | | method | limit/base | current | history1 | history2 |
|---|---|---|---|---|---|---|
| Particles >4µm | | ASTM D7647 | >2500 | ▲ **6565** | ▲ 6178 | 546 |
| Particles >6µm | | ASTM D7647 | >640 | ▲ **2428** | ▲ 787 | 110 |
| Particles >14µm | | ASTM D7647 | >80 | ▲ **336** | 35 | 9 |
| Particles >21µm | | ASTM D7647 | >20 | ▲ **100** | 9 | 3 |
| Oil Cleanliness | | ISO 4406 (c) | >18/16/13 | ▲ **20/18/16** | ▲ 20/17/12 | 16/14/10 |

**Recommendation**
We advise that you perform a filter service, and use off-line filtration to improve the cleanliness of the system fluid. We recommend an early resample to monitor this condition.
