Customer Id: LINORA
Sample No.: PH0003680
Lab Number: 06029981
Test Package: PLANT

OIL ANALYSIS REPORT

Machine Id
HI CELL II
Component
Hydraulic System
Fluid
MOBIL DTE ULTRA 24 ISO 32 (--- GAL)

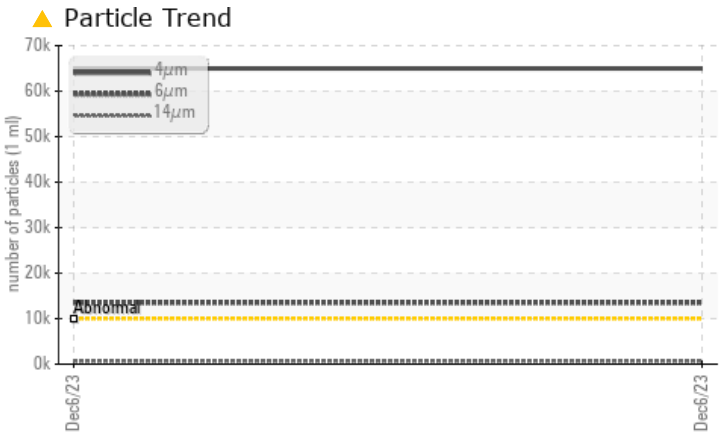
COMPONENT CONDITION SUMMARY

Sample Status				**ABNORMAL**	---	---
Particles >4µm		ASTM D7647	>10000	▲ **64973**	---	---
Particles >6µm		ASTM D7647	>2500	▲ **13515**	---	---
Particles >14µm		ASTM D7647	>320	▲ **646**	---	---
Particles >21µm		ASTM D7647	>80	▲ **176**	---	---
Oil Cleanliness		ISO 4406 (c)	>20/18/15	▲ **23/21/17**	---	---
PrtFilter

We recommend you service the filters on this component. Resample at the next service interval to monitor.

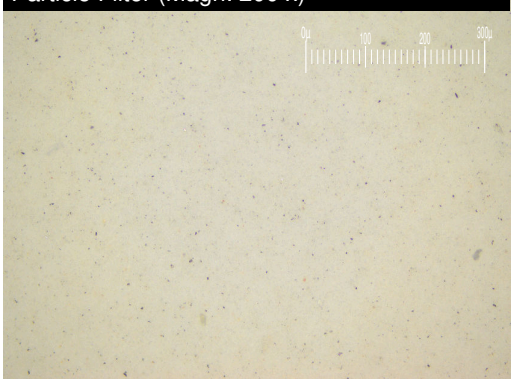
Particle Filter (Magn: 200 x)

Contamination
There is a high amount of particulates present in the oil.

Recommendation
We recommend you service the filters on this component. Resample at the next service interval to monitor.

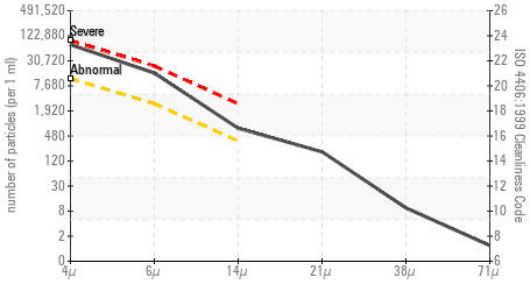
Particle Count

FLUID CLEANLINESS		method	limit/base	current	history1	history2
Particles >4µm		ASTM D7647	>10000	▲ **64973**	---	---
Particles >6µm		ASTM D7647	>2500	▲ **13515**	---	---
Particles >14µm		ASTM D7647	>320	▲ **646**	---	---
Particles >21µm		ASTM D7647	>80	▲ **176**	---	---
Particles >38µm		ASTM D7647	>20	**8**	---	---
Particles >71µm		ASTM D7647	>4	**1**	---	---
Oil Cleanliness		ISO 4406 (c)	>20/18/15	▲ **23/21/17**	---	---

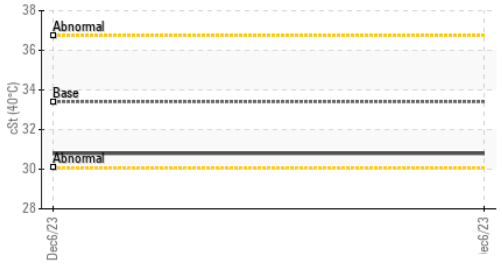
Viscosity @ 40°C

FLUID PROPERTIES		method	limit/base	current	history1	history2
Visc @ 40°C	cSt	ASTM D445	33.4	**30.8**	---	---

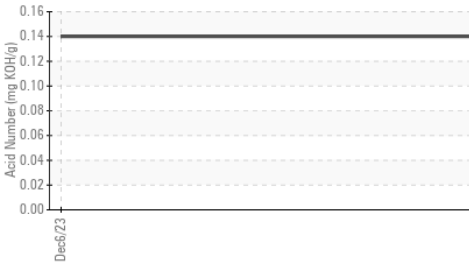
Fluid Condition
The AN level is acceptable for this fluid. The condition of the oil is suitable for further service.

FLUID DEGRADATION		method	limit/base	current	history1	history2
Acid Number (AN)	mg KOH/g	ASTM D8045		**0.14**	---	---
