Customer Id: PLAROM
Sample No.: RP0038669
Lab Number: 06061097
Test Package: IND 2

OIL ANALYSIS REPORT

Machine Id
MACHINE 27 (S/N 77110)
Component
Hydraulic System
Fluid
ESSO NUTO H ISO 46 (450 GAL)

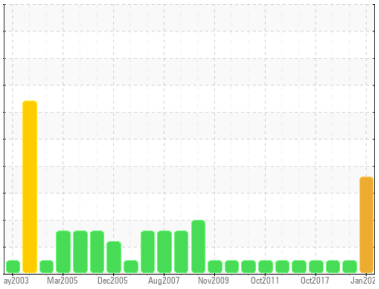
Sample Rating Trend

Sample Status				SEVERE	NORMAL	NORMAL
Particles >4µm		ASTM D7647	>5000	**148240**	288	400
Particles >6µm		ASTM D7647	>1300	**44247**	76	115
Oil Cleanliness		ISO 4406 (c)	>19/17/14	**24/23/12**	15/13/10	16/14/11

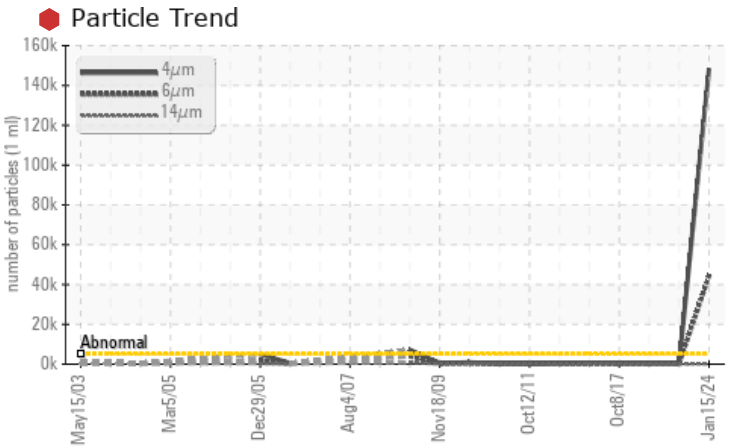
COMPONENT CONDITION SUMMARY

There is a high amount of silt (particulates < 14 microns in size) present in the oil. The water content is negligible.

Check seals and/or filters for points of contaminant entry. The air breather requires service. If unrated, we recommend that you replace with a suitable micron rated and/or desiccant air breather. If rated, we recommend that you service/replace the breather. We recommend you service the filters on this component. Resample in 30-45 days to monitor this situation.

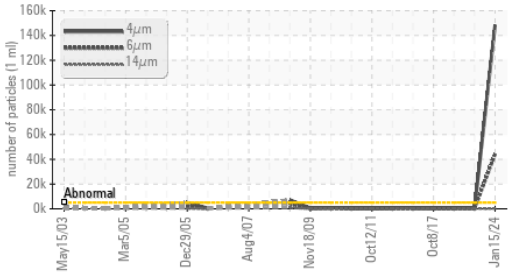
Particle Trend

FLUID CLEANLINESS	method	limit/base	current	history1	history2
Particles >4µm	ASTM D7647	>5000	**148240**	288	400
Particles >6µm	ASTM D7647	>1300	**44247**	76	115
Particles >14µm	ASTM D7647	>160	**30**	9	20
Particles >21µm	ASTM D7647	>40	**1**	4	8
Particles >38µm	ASTM D7647	>10	**0**	0	1
Particles >71µm	ASTM D7647	>3	**0**	0	0
Oil Cleanliness	ISO 4406 (c)	>19/17/14	**24/23/12**	15/13/10	16/14/11
