# OIL ANALYSIS REPORT

Machine Id
## HIAB 50607
Component
**Hydraulic System**
Fluid
**AW HYDRAULIC OIL ISO 32 (--- GAL)**

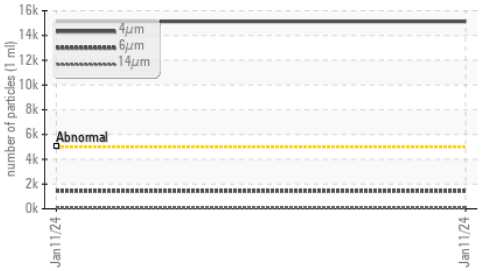
Particle Trend

**Contamination**
There is a high amount of silt (particulates < 14 microns in size) present in the oil.

**Recommendation**
No corrective action is recommended at this time. The filter change at the time of sampling has been noted. Resample at the next service interval to monitor.

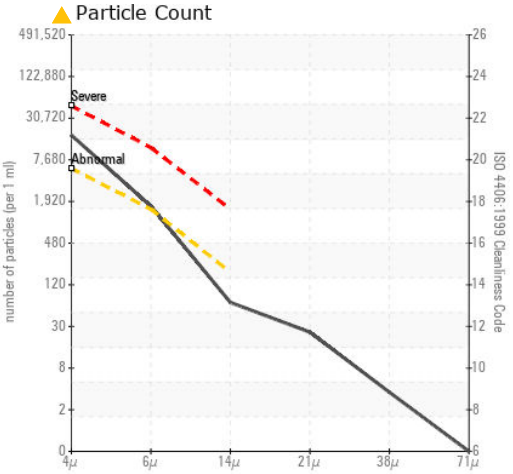
Particle Count

| FLUID CLEANLINESS | | method | limit/base | current | history1 | history2 |
|---|---|---|---|---|---|---|
| Oil Cleanliness | | ISO 4406 (c) | >19/17/14 | ▲ **21/18/13** | --- | --- |
