OIL ANALYSIS REPORT

Area
COMPRESSOR STATIONS/RED HILLS EAST AREA
Machine Id
CABALLO (S/N 5629X2455)
Component
Compressor
Fluid
TULCO LUBSOIL LPG WS 150 (--- GAL)

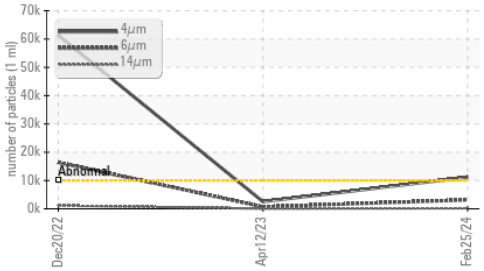
Particle Trend

Contamination
There is a high amount of silt (particulates < 14 microns in size) present in the oil.

FLUID CLEANLINESS		method	limit/base	current	history1	history2
Particles >4µm		ASTM D7647	>10000	● **11197**	2542	▲ 61284
Particles >6µm		ASTM D7647	>1300	▲ **3151**	692	▲ 16416
Particles >14µm		ASTM D7647	>320	**191**	46	▲ 1151
Particles >21µm		ASTM D7647	>80	**37**	12	▲ 310
Particles >38µm		ASTM D7647	>20	**6**	0	▲ 21
Particles >71µm		ASTM D7647	>4	**4**	0	3
Oil Cleanliness		ISO 4406 (c)	>20/17/15	▲ **21/19/15**	19/17/13	▲ 23/21/17

Recommendation
No corrective action is recommended at this time. Resample at the next service interval to monitor.
