Hilcorp Alaska, LLC

OIL ANALYSIS REPORT

Area
IRIG [6606319]
Machine Id
IRIG-PRM-PMUD-0302 - 2MP IRIG-PRM-PMUD-0302 #2 MUD PUMP
Component
Pump
Fluid
MOBIL SHC 632 (--- GAL)

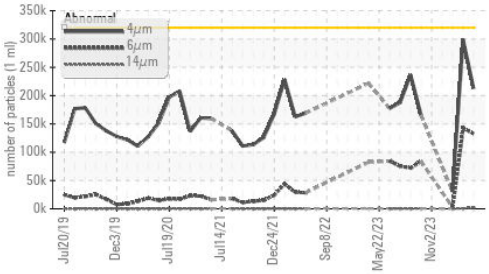
Particle Trend

There is a high amount of particulates present in the oil. Elemental levels of silicon (Si) and aluminum (Al) indicate alumina-silicate (coarse dirt) ingress.

FLUID CLEANLINESS		method	limit/base	current	history1	history2
Particles >4µm		ASTM D7647	>320000	**212407**	298950	30105
Particles >6µm		ASTM D7647	>40000	▲ **132883**	▲ 142248	2386
Particles >14µm		ASTM D7647	>640	▲ **1737**	598	25
Particles >21µm		ASTM D7647	>160	**33**	58	6
Particles >38µm		ASTM D7647	>40	**2**	0	1
Particles >71µm		ASTM D7647	>10	**2**	0	1
Oil Cleanliness		ISO 4406 (c)	>25/22/16	▲ **25/24/18**	▲ 25/24/16	22/18/12

We advise that you check all areas where dirt can enter the system. We recommend you service the filters on this component if applicable. Resample at the next service interval to monitor.

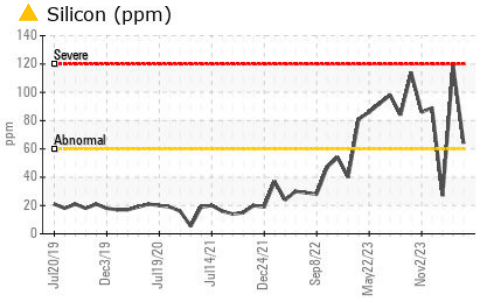
Silicon (ppm)

CONTAMINANTS		method	limit/base	current	history1	history2
Silicon	ppm	ASTM D5185m	>60	▲ **64**	▲ 119	27
Sodium	ppm	ASTM D5185m		**24**	49	2
Potassium	ppm	ASTM D5185m	>20	**23**	44	<1

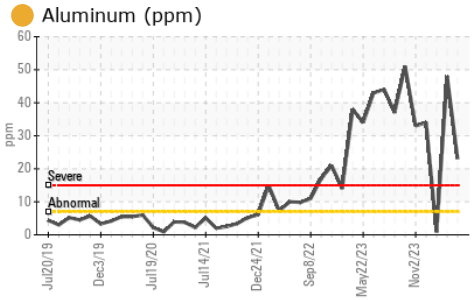
Aluminum (ppm)

WEAR METALS		method	limit/base	current	history1	history2
Iron	ppm	ASTM D5185m	>90	**30**	58	2
Chromium	ppm	ASTM D5185m	>5	**1**	3	0
Nickel	ppm	ASTM D5185m	>5	**0**	0	0
Titanium	ppm	ASTM D5185m	>3	**1**	3	0
Silver	ppm	ASTM D5185m	>3	**0**	0	0
Aluminum	ppm	ASTM D5185m	>7	● **23**	● 48	<1
Lead	ppm	ASTM D5185m	>12	**0**	0	0
Copper	ppm	ASTM D5185m	>30	**4**	7	0
Tin	ppm	ASTM D5185m	>9	**<1**	<1	0
Vanadium	ppm	ASTM D5185m		**0**	0	0
Cadmium	ppm	ASTM D5185m		**0**	0	0
