Customer Id: UCDANLAF
Sample No.: FCH0000049
Lab Number: 06135128
Test Package: PLANT

OIL ANALYSIS REPORT

Machine Id
N/a DNL FEEDSTOCK 002
Component
Machining Fluid
Fluid
{not provided} (--- GAL)

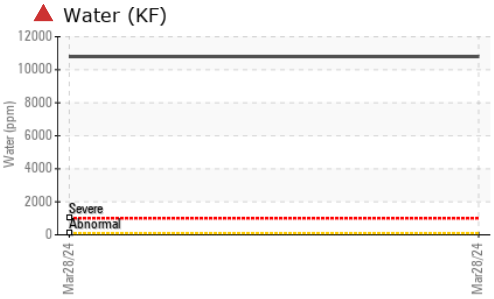
Water (KF)

▲ Contamination
There is a high amount of particulates present in the machining fluid. There is a high concentration of water present in the machining fluid. There is a moderate amount of visible silt present in the sample.

▲ Recommendation
We advise that you check for the source of water entry. We recommend an early resample to monitor this condition. Please note that this is a corrected copy for laboratory data updates to update particle count.

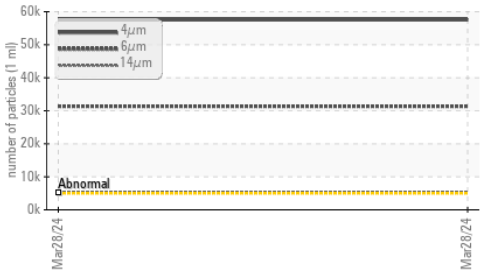
Particle Trend

FLUID CLEANLINESS		method	limit/base	current	history1	history2
Particles >4µm		ASTM D7647	>5000	▲ **57548**	---	---
Particles >6µm		ASTM D7647	>1300	▲ **31350**	---	---
Particles >14µm		ASTM D7647	>160	▲ **5335**	---	---
Particles >21µm		ASTM D7647	>40	▲ **1797**	---	---
Particles >38µm		ASTM D7647	>10	▲ **277**	---	---
Particles >71µm		ASTM D7647	>3	▲ **28**	---	---
Oil Cleanliness		ISO 4406 (c)	>19/17/14	▲ **23/22/20**	---	---

We advise that you check for the source of water entry. We recommend an early resample to monitor this condition. Please note that this is a corrected copy for laboratory data updates to update particle count.

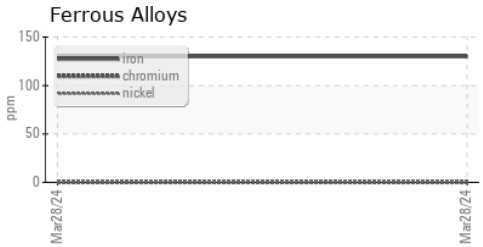
Ferrous Alloys

Wear
All component wear rates are normal.

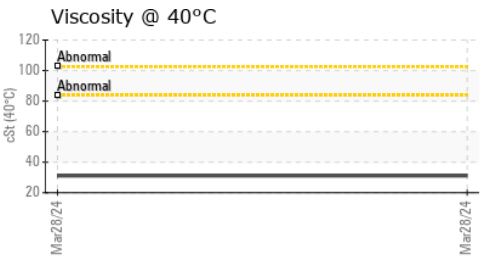
Viscosity @ 40°C

FLUID PROPERTIES		method	limit/base	current	history1	history2
Visc @ 40°C	cSt	ASTM D445		**31.1**	---	---

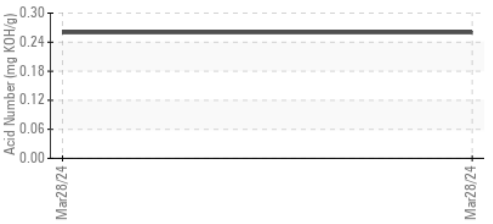
Acid Number

Fluid Condition
The AN level is acceptable for this fluid.
