OIL ANALYSIS REPORT

Area
KANSAS/44/EG - EXCAVATOR
Machine Id
20.205L [KANSAS^44^EG - EXCAVATOR]
Component
Right Final Drive
Fluid
MOBIL MOBILTRANS HD 50 (--- GAL)

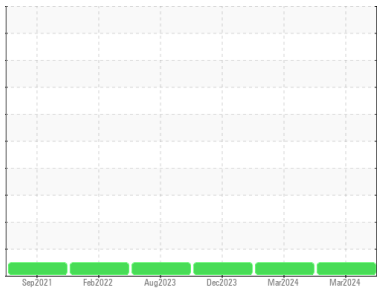
Sample Rating Trend

NORMAL

Wear
All component wear rates are normal.

Contamination
There is no indication of any contamination in the oil.

Fluid Condition
The condition of the oil is acceptable for the time in service.

Recommendation
Resample at the next service interval to monitor.
