Machine Id
LINDE 5255
Component
Diesel Engine
Fluid
{not provided} (--- GAL)

Customer Id: ALTAMA
Sample No.: PE0002463
Lab Number: 06138277
Test Package: CONST

OIL ANALYSIS REPORT

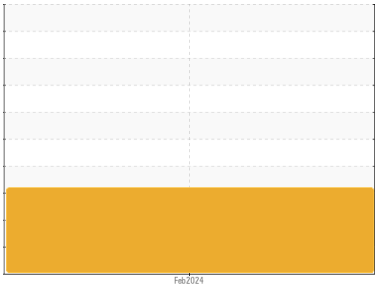
Sample Rating Trend

Sample Status				**SEVERE**	---	---
Iron	ppm	ASTM D5185m	>100	▲ **147**	---	---
Fuel	%	ASTM D3524	>5	▲ **11.0**	---	---
Visc @ 100°C	cSt	ASTM D445		▲ **10.2**	---	---

We advise that you check the fuel injection system. We recommend that you drain the oil and perform a filter service on this component if not already done. We recommend an early resample to monitor this condition. Please specify the brand, type, and viscosity of the oil on your next sample.

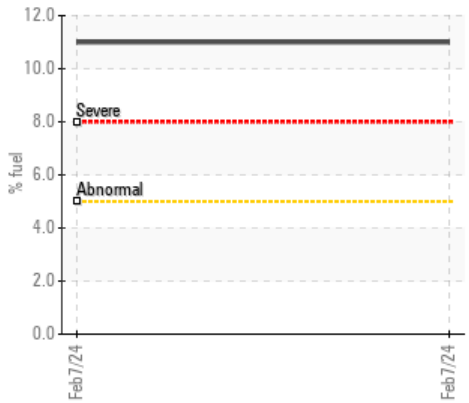
▲ Fuel Dilution

Contamination
There is a high amount of fuel present in the oil.

Fluid Condition
Fuel is present in the oil and is lowering the viscosity. The oil is no longer serviceable due to the presence of contaminants.

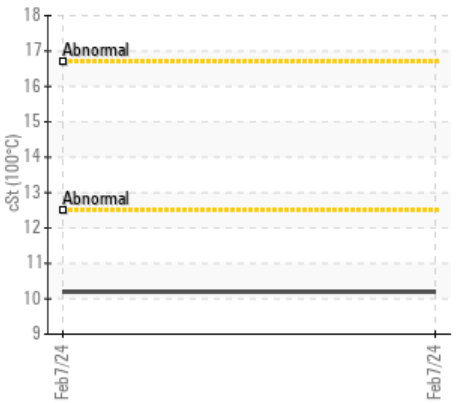
▲ Viscosity @ 100°C

FLUID PROPERTIES		method	limit/base	current	history1	history2
Visc @ 100°C	cSt	ASTM D445		▲ **10.2**	---	---

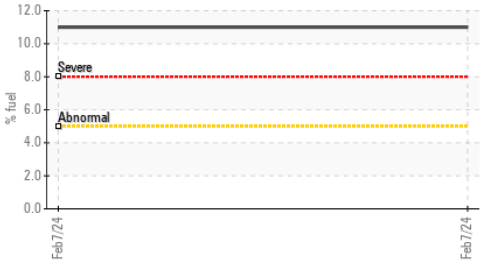
Fuel Dilution

CONTAMINANTS		method	limit/base	current	history1	history2
Silicon	ppm	ASTM D5185m	>25	**24**	---	---
Sodium	ppm	ASTM D5185m		**6**	---	---
Potassium	ppm	ASTM D5185m	>20	**5**	---	---
Fuel	%	ASTM D3524	>5	▲ **11.0**	---	---

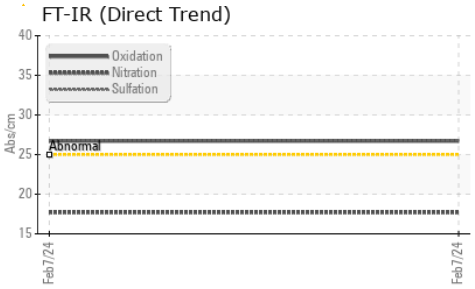
FT-IR (Direct Trend)

INFRA-RED		method	limit/base	current	history1	history2
Soot %	%	*ASTM D7844	>3	**1.5**	---	---
Nitration	Abs/cm	*ASTM D7624	>20	**17.7**	---	---
Sulfation	Abs/.1mm	*ASTM D7415	>30	**26.8**	---	---

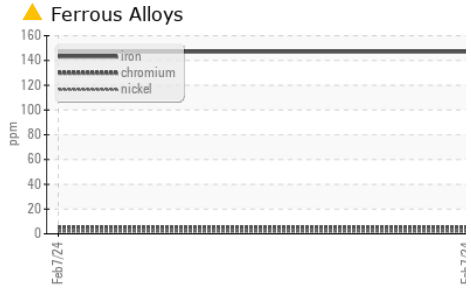
Ferrous Alloys

WEAR METALS		method	limit/base	current	history1	history2
Iron	ppm	ASTM D5185m	>100	▲ **147**	---	---
Chromium	ppm	ASTM D5185m	>20	**5**	---	---
Nickel	ppm	ASTM D5185m	>4	**2**	---	---
Titanium	ppm	ASTM D5185m		**<1**	---	---
Silver	ppm	ASTM D5185m	>3	**0**	---	---
Aluminum	ppm	ASTM D5185m	>20	**17**	---	---
Lead	ppm	ASTM D5185m	>40	**<1**	---	---
Copper	ppm	ASTM D5185m	>330	**16**	---	---
Tin	ppm	ASTM D5185m	>15	**<1**	---	---
Vanadium	ppm	ASTM D5185m		**<1**	---	---
Cadmium	ppm	ASTM D5185m		**<1**	---	---

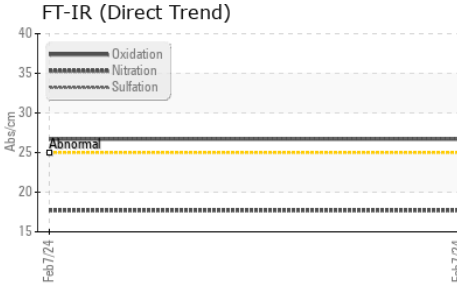
FT-IR (Direct Trend)

FLUID DEGRADATION		method	limit/base	current	history1	history2
Oxidation	Abs/.1mm	*ASTM D7414	>25	**26.7**	---	---
Base Number (BN)	mg KOH/g	ASTM D2896		**8.0**	---	---

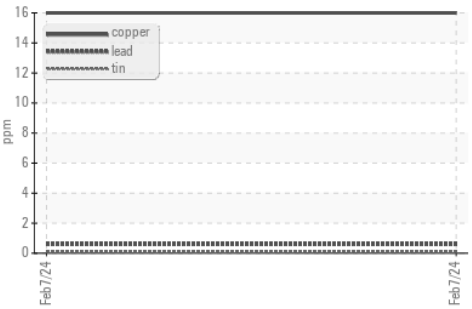
Non-ferrous Metals

Wear
All component wear rates are normal.
