OIL ANALYSIS REPORT

Machine Id
KAESER 6387902
Component
Compressor
Fluid
KAESER SIGMA (OEM) M-460 (--- QTS)

Laboratory : WearCheck USA - 501 Madison Ave., Cary, NC 27513
Sample No. : KCPA016344
Lab Number : 06142252
Unique Number : 10967060
Test Package : IND 2 (Additional Tests: KF, PrtCount)

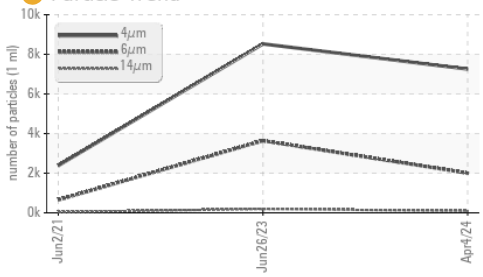
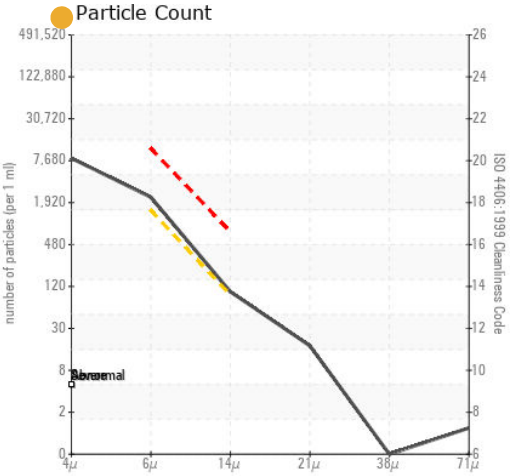
Particle Trend

Contamination
There is a moderate amount of particulates present in the oil.

FLUID CLEANLINESS		method	limit/base	current	history1	history2
Particles >4µm		ASTM D7647		**7256**	8526	2387
Particles >6µm		ASTM D7647	>1300	**2005**	3640	651
Particles >14µm		ASTM D7647	>80	**89**	194	34
Particles >21µm		ASTM D7647	>20	**15**	38	7
Particles >38µm		ASTM D7647	>4	**0**	3	0
Particles >71µm		ASTM D7647	>3	**1**	0	0
Oil Cleanliness		ISO 4406 (c)	>--/17/13	**20/18/14**	20/19/15	17/12

Recommendation
No corrective action is recommended at this time. Oil and filter change at the time of sampling has been noted. Resample at the next service interval to monitor.
