Machine Id
TB-5 REDUCER
Component
Gearbox
Fluid
CHEVRON MEROPA 220 (20 GAL)

Customer Id: HYDBELFL
Sample No.: ST43263
Lab Number: 06143042
Test Package: IND 2

OIL ANALYSIS REPORT

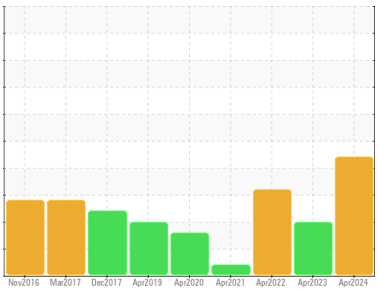
Sample Rating Trend

Sample Status				SEVERE	ABNORMAL	SEVERE
Particles >4µm		ASTM D7647	>1300	▲ **108919**	▲ 221616	▲ 111348
Particles >6µm		ASTM D7647	>320	▲ **15505**	▲ 157190	▲ 10500
Particles >14µm		ASTM D7647	>80	▲ **352**	▲ 5915	● 93
Particles >21µm		ASTM D7647	>20	▲ **60**	▲ 220	13
Oil Cleanliness		ISO 4406 (c)	>17/15/13	▲ **24/21/16**	▲ 25/24/20	▲ 24/21/14

We advise that you check all areas where contaminants can enter the system. We advise that you perform a filter service, and use off-line filtration to improve the cleanliness of the system fluid. The air breather requires service. If unrated, we recommend that you replace with a suitable micron rated and/or desiccant air breather. If rated, we recommend that you service/replace the breather. Resample in 30-45 days to monitor this situation.

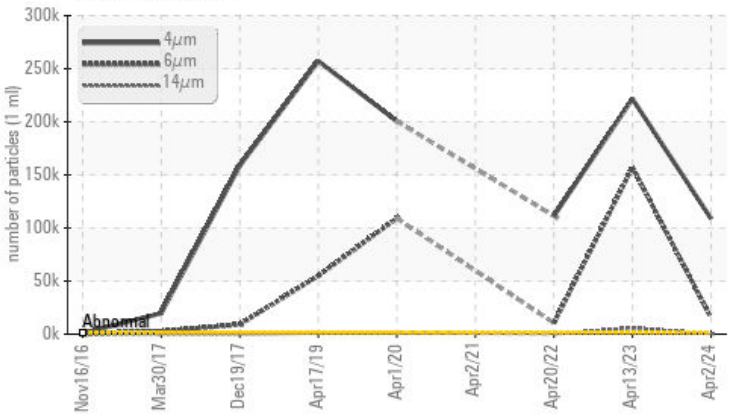
Particle Trend

▲ Contamination
There is a high amount of particulates (2 to 100 microns in size) present in the oil. The water content is negligible. The system cleanliness code is much higher than the acceptable limit for the target ISO 4406 cleanliness code.

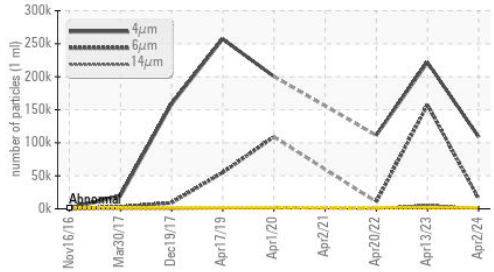
Particle Trend

FLUID CLEANLINESS		method	limit/base	current	history1	history2
Particles >4µm		ASTM D7647	>1300	▲ **108919**	▲ 221616	▲ 111348
Particles >6µm		ASTM D7647	>320	▲ **15505**	▲ 157190	▲ 10500
Particles >14µm		ASTM D7647	>80	▲ **352**	▲ 5915	● 93
Particles >21µm		ASTM D7647	>20	▲ **60**	▲ 220	13
Particles >38µm		ASTM D7647	>4	**2**	4	0
Particles >71µm		ASTM D7647	>3	**0**	0	0
Oil Cleanliness		ISO 4406 (c)	>17/15/13	▲ **24/21/16**	▲ 25/24/20	▲ 24/21/14

▲ Recommendation
We advise that you check all areas where contaminants can enter the system. We advise that you perform a filter service, and use off-line filtration to improve the cleanliness of the system fluid. The air breather requires service. If unrated, we recommend that you replace with a suitable micron rated and/or desiccant air breather. If rated, we recommend that you service/replace the breather. Resample in 30-45 days to monitor this situation.
