Customer Id: HYDBELFL
Sample No.: ST46892
Lab Number: 06143047
Test Package: IND 2

OIL ANALYSIS REPORT

Machine Id
TA-5 REDUCER
Component
Gearbox
Fluid
CHEVRON MEROPA 220 (20 GAL)

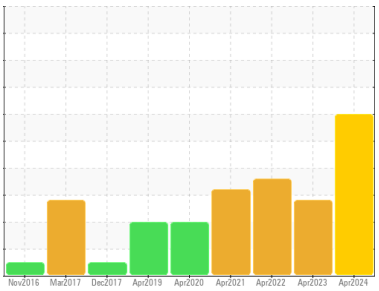
Sample Rating Trend

ISO

Sample Status				SEVERE	ABNORMAL	SEVERE
Particles >4µm		ASTM D7647	>1300	▲ **110154**	▲ 160973	▲ 72122
Particles >6µm		ASTM D7647	>320	▲ **23447**	▲ 63643	▲ 11656
Particles >14µm		ASTM D7647	>80	▲ **643**	▲ 3671	▲ 288
Particles >21µm		ASTM D7647	>20	▲ **117**	▲ 562	▲ 47
Oil Cleanliness		ISO 4406 (c)	>17/15/13	▲ **24/22/17**	▲ 25/23/19	▲ 23/21/15

We advise that you check all areas where contaminants can enter the system. We advise that you perform a filter service, and use off-line filtration to improve the cleanliness of the system fluid. The air breather requires service. If unrated, we recommend that you replace with a suitable micron rated and/or desiccant air breather. If rated, we recommend that you service/replace the breather. Resample in 30-45 days to monitor this situation.

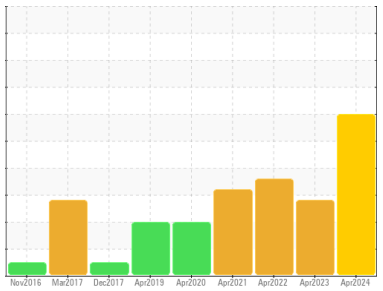
Sample Rating Trend

ISO

▲ Contamination
There is a high amount of particulates (2 to 100 microns in size) present in the oil. The water content is negligible. The system cleanliness code is much higher than the acceptable limit for the target ISO 4406 cleanliness code.

▲ Recommendation
We advise that you check all areas where contaminants can enter the system. We advise that you perform a filter service, and use off-line filtration to improve the cleanliness of the system fluid. The air breather requires service. If unrated, we recommend that you replace with a suitable micron rated and/or desiccant air breather. If rated, we recommend that you service/replace the breather. Resample in 30-45 days to monitor this situation.

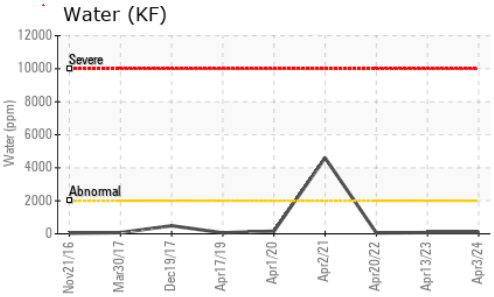
Water (KF)

CONTAMINANTS		method	limit/base	current	history1	history2
Silicon	ppm	ASTM D5185m	>50	**4**	4	7
Sodium	ppm	ASTM D5185m		**2**	1	<1
Potassium	ppm	ASTM D5185m	>20	**<1**	<1	2
Water	%	ASTM D6304	>0.2	**0.007**	0.007	0.005
ppm Water	ppm	ASTM D6304	>2000	**74**	75.7	53.9

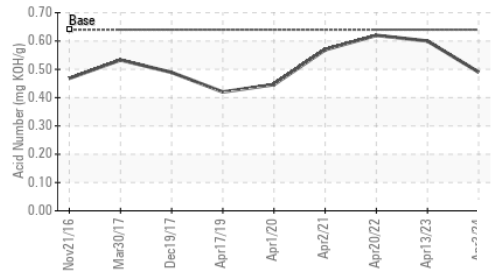
Fluid Condition
The AN level is acceptable for this fluid. The oil is still serviceable provided that the contaminant(s) can be reduced to acceptable levels.

FLUID DEGRADATION		method	limit/base	current	history1	history2
Acid Number (AN)	mg KOH/g	ASTM D8045	0.64	**0.49**	0.60	0.62

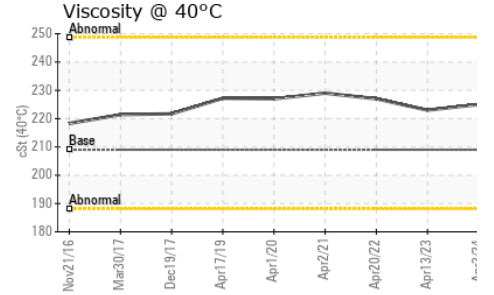
Viscosity @ 40°C

FLUID PROPERTIES		method	limit/base	current	history1	history2
Visc @ 40°C	cSt	ASTM D445	209	**225**	223	227

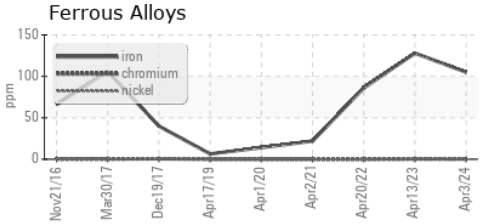
Ferrous Alloys

Wear
All component wear rates are normal.

WEAR METALS		method	limit/base	current	history1	history2
Iron	ppm	ASTM D5185m	>200	**105**	128	86
Chromium	ppm	ASTM D5185m	>15	**<1**	<1	0
Nickel	ppm	ASTM D5185m	>15	**0**	<1	0
Titanium	ppm	ASTM D5185m		**<1**	0	0
Silver	ppm	ASTM D5185m		**0**	0	0
Aluminum	ppm	ASTM D5185m	>25	**<1**	<1	<1
Lead	ppm	ASTM D5185m	>100	**0**	0	<1
Copper	ppm	ASTM D5185m	>200	**4**	3	5
Tin	ppm	ASTM D5185m	>25	**<1**	0	0
Antimony	ppm	ASTM D5185m	>5	**---**	---	---
Vanadium	ppm	ASTM D5185m		**<1**	0	0
Cadmium	ppm	ASTM D5185m		**0**	0	<1

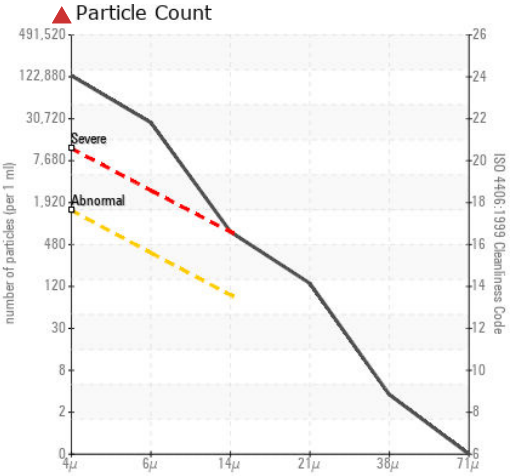
Particle Count

FLUID CLEANLINESS		method	limit/base	current	history1	history2
Particles >4µm		ASTM D7647	>1300	▲ **110154**	▲ 160973	▲ 72122
Particles >6µm		ASTM D7647	>320	▲ **23447**	▲ 63643	▲ 11656
Particles >14µm		ASTM D7647	>80	▲ **643**	▲ 3671	▲ 288
Particles >21µm		ASTM D7647	>20	▲ **117**	▲ 562	▲ 47
Particles >38µm		ASTM D7647	>4	**3**	▲ 39	0
Particles >71µm		ASTM D7647	>3	**0**	▲ 3	0
Oil Cleanliness		ISO 4406 (c)	>17/15/13	▲ **24/22/17**	▲ 25/23/19	▲ 23/21/15
