Machine Id
TA-7 REDUCER
Component
Gearbox
Fluid
CHEVRON MEROPA 220 (20 GAL)

Customer Id: HYDBELFL
Sample No.: ST46589
Lab Number: 06143070
Test Package: IND 2

OIL ANALYSIS REPORT

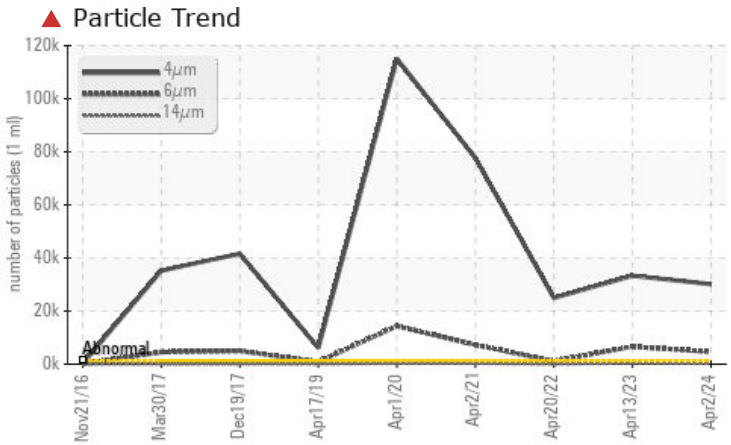
COMPONENT CONDITION SUMMARY

Sample Status				SEVERE	ABNORMAL	SEVERE
Particles >4µm		ASTM D7647	>1300	▲ **30117**	▲ 33324	▲ 24937
Particles >6µm		ASTM D7647	>320	▲ **4659**	▲ 6578	▲ 1116
Particles >14µm		ASTM D7647	>80	▲ **206**	▲ 382	21
Particles >21µm		ASTM D7647	>20	▲ **47**	▲ 82	4
Oil Cleanliness		ISO 4406 (c)	>17/15/13	▲ **22/19/15**	▲ 22/20/16	▲ 22/17/12

▲ Contamination
There is a high amount of particulates (2 to 100 microns in size) present in the oil. The water content is negligible. The system cleanliness code is much higher than the acceptable limit for the target ISO 4406 cleanliness code.

We advise that you check all areas where contaminants can enter the system. We advise that you perform a filter service, and use off-line filtration to improve the cleanliness of the system fluid. The air breather requires service. If unrated, we recommend that you replace with a suitable micron rated and/or desiccant air breather. If rated, we recommend that you service/replace the breather. Resample in 30-45 days to monitor this situation.

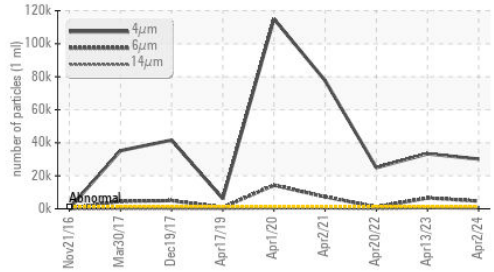
Particle Trend

FLUID CLEANLINESS		method	limit/base	current	history1	history2
Particles >4µm		ASTM D7647	>1300	▲ **30117**	▲ 33324	▲ 24937
Particles >6µm		ASTM D7647	>320	▲ **4659**	▲ 6578	▲ 1116
Particles >14µm		ASTM D7647	>80	▲ **206**	▲ 382	21
Particles >21µm		ASTM D7647	>20	▲ **47**	▲ 82	4
Particles >38µm		ASTM D7647	>4	**3**	▲ 10	0
Particles >71µm		ASTM D7647	>3	**1**	0	0
Oil Cleanliness		ISO 4406 (c)	>17/15/13	▲ **22/19/15**	▲ 22/20/16	▲ 22/17/12

▲ Recommendation
We advise that you check all areas where contaminants can enter the system. We advise that you perform a filter service, and use off-line filtration to improve the cleanliness of the system fluid. The air breather requires service. If unrated, we recommend that you replace with a suitable micron rated and/or desiccant air breather. If rated, we recommend that you service/replace the breather. Resample in 30-45 days to monitor this situation.
