Hilcorp Alaska, LLC

OIL ANALYSIS REPORT

Area
Turbines and Generators
Machine Id
GT 0801 GT 0801
Component
Turbine
Fluid
MOBIL JET OIL II (50 GAL)

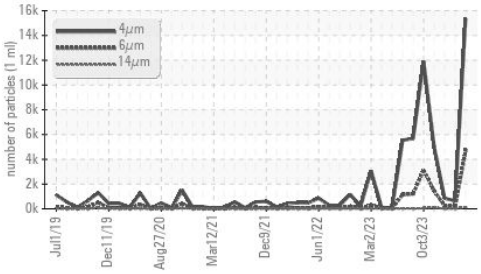
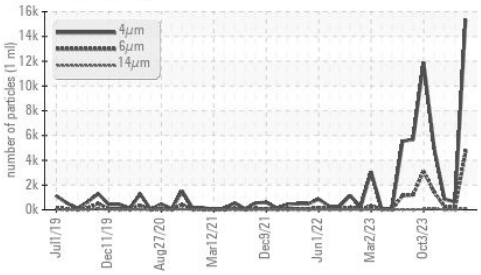
Particle Trend

Contamination
There is a high amount of silt (particulates < 14 microns in size) present in the oil.

Recommendation
We recommend you service the filters on this component if applicable. Resample at the next service interval to monitor.

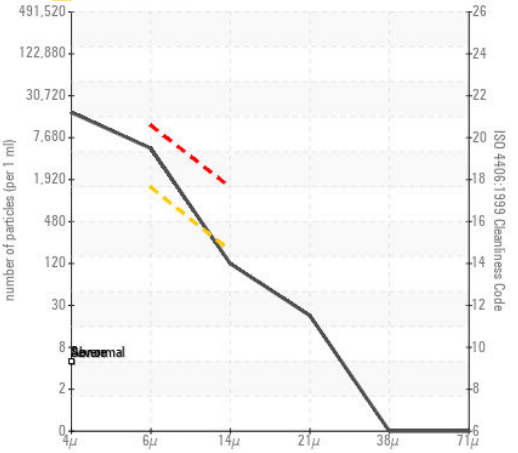
Particle Count

FLUID CLEANLINESS		method	limit/base	current	history1	history2
Particles >4µm		ASTM D7647		**15352**	649	847
Particles >6µm		ASTM D7647	>1300	▲ **4692**	205	212
Particles >14µm		ASTM D7647	>160	**105**	9	12
Particles >21µm		ASTM D7647	>40	**19**	3	3
Particles >38µm		ASTM D7647	>10	**0**	0	0
Particles >71µm		ASTM D7647	>3	**0**	0	0
Oil Cleanliness		ISO 4406 (c)	>--/17/14	▲ **21/19/14**	17/15/10	17/15/11
