Customer Id: METWIX
Sample No.: PH0003468
Lab Number: 06150311
Test Package: PLANT

OIL ANALYSIS REPORT

Machine Id
AZTEC MACHINE
Component
Hydraulic System
Fluid
VG-32 (5 GAL)

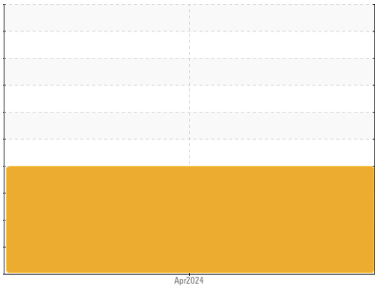
Sample Rating Trend

WATER

Sample Status				**SEVERE**	---	---
Water	%	ASTM D6304	>0.05	▲ **1.26**	---	---
ppm Water	ppm	ASTM D6304	>500	▲ **12600**	---	---
Emulsified Water	scalar	*Visual	>0.05	▲ **0.2%**	---	---
PrtFilter

We advise that you check for the source of water entry. We advise that you perform a filter service, and use off-line filtration to improve the cleanliness of the system fluid. We recommend an early resample to monitor this condition.

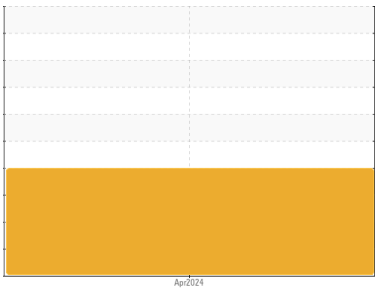
Sample Rating Trend

WATER

▲ Contamination
Appearance is unacceptable There is a high concentration of water present in the oil. The amount and size of particulates present in the system are acceptable.

▲ Recommendation
We advise that you check for the source of water entry. We advise that you perform a filter service, and use off-line filtration to improve the cleanliness of the system fluid. We recommend an early resample to monitor this condition.

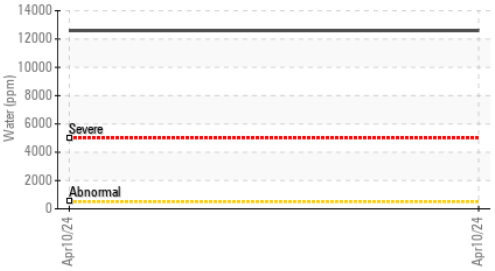
Water (KF)

CONTAMINANTS		method	limit/base	current	history1	history2
Silicon	ppm	ASTM D5185m	>15	**<1**	---	---
Sodium	ppm	ASTM D5185m		**2**	---	---
Potassium	ppm	ASTM D5185m	>20	**<1**	---	---
Water	%	ASTM D6304	>0.05	▲ **1.26**	---	---
ppm Water	ppm	ASTM D6304	>500	▲ **12600**	---	---
