PROBLEM SUMMARY

Area
[W02008185]
Machine Id
VOLVO A30F 82248
Component
Front Axle
Fluid
{not provided} (11 GAL)

OIL ANALYSIS REPORT

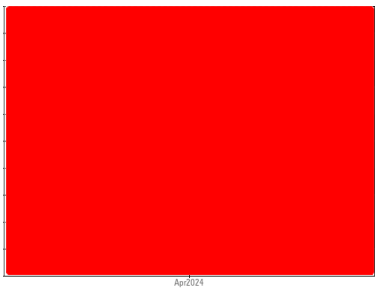
Sample Rating Trend

WEAR

Sample Status				**SEVERE**	---	---
Iron	ppm	ASTM D5185m	>630	▲ **1025**	---	---
Copper	ppm	ASTM D5185m	>50	▲ **87**	---	---
Tin	ppm	ASTM D5185m	>4	▲ **5**	---	---
Silicon	ppm	ASTM D5185m	>50	▲ **100**	---	---

We advise that you check all areas where dirt can enter the system. The oil change at the time of sampling has been noted. We advise that you inspect for the source(s) of wear. We recommend an early resample to monitor this condition. (Customer Sample Comment: W02008185)

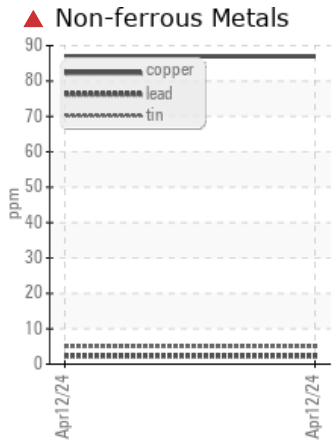
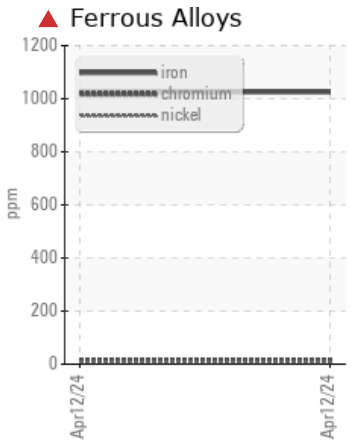
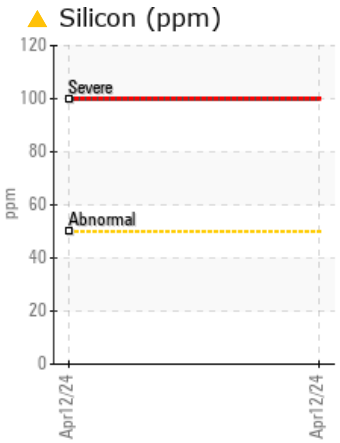
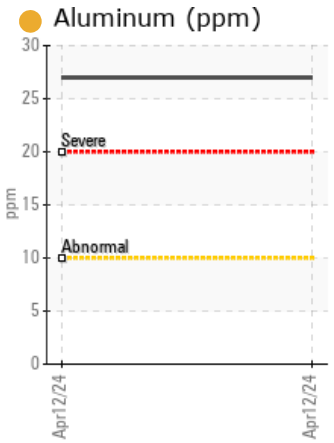
COMPONENT CONDITION SUMMARY

▲ Wear
Gear wear is indicated. Bearing and/or bushing wear is indicated.

▲ Contamination
Elemental levels of silicon (Si) and aluminum (Al) indicate alumina-silicate (coarse dirt) ingress.

Fluid Condition
The oil is no longer serviceable as a result of the abnormal and/or severe wear.
