OIL ANALYSIS REPORT

Area
PLOGER
Machine Id
821 - PLOGER
Component
Front Differential
Fluid
{not provided} (--- GAL)

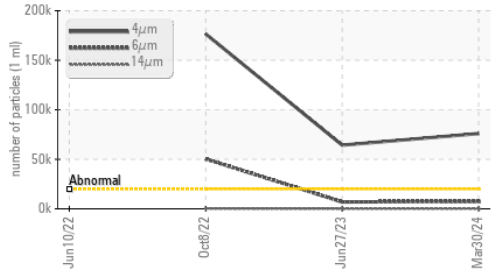
Particle Trend

Contamination
There is a high amount of silt (particulates < 14 microns in size) present in the oil.

FLUID CLEANLINESS		method	limit/base	current	history1	history2
Particles >4µm		ASTM D7647	>20000	▲ **75981**	▲ 64264	▲ 176491
Particles >6µm		ASTM D7647	>5000	● **7376**	● 6943	▲ 50340
Particles >14µm		ASTM D7647	>640	**125**	126	200
Particles >21µm		ASTM D7647	>160	**24**	19	13
Particles >38µm		ASTM D7647	>40	**1**	2	0
Particles >71µm		ASTM D7647	>10	**0**	2	0
Oil Cleanliness		ISO 4406 (c)	>21/19/16	▲ **23/20/14**	▲ 23/20/14	▲ 25/23/15

Recommendation
No corrective action is recommended at this time. Resample at the next service interval to monitor.
