OIL ANALYSIS REPORT

Area
GUAY SON [CONHER]
Machine Id
IBACO BM LOPEZ VENTURA
Component
Diesel Engine
Fluid
RALOY 15W40 (160 LTR)

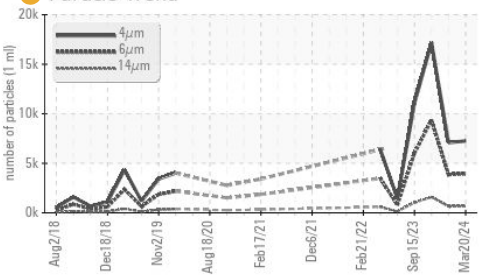
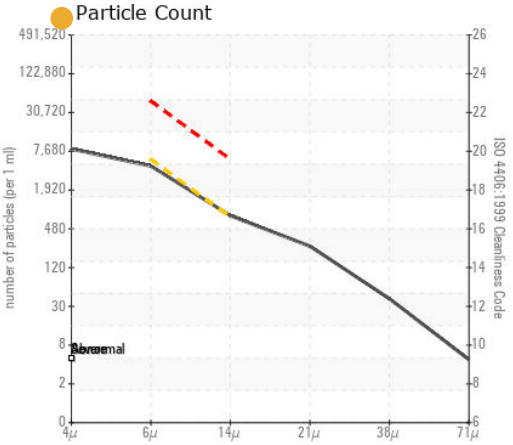
Contamination
There is a moderate amount of particulates present in the oil.

Recommendation
No corrective action is recommended at this time. Resample at the next service interval to monitor. (Customer Sample Comment: Fluid: Raloy 15W40)
